## Community Assessment

## El Sobrante Landfill: Community Assessment

Date: March 5, 2024 Arrival time: 11:00 am Prepared by: Katherine Avila/Kinika Hesterly, RCDWR

El Sobrante Landfill  
Quarterly Mitigation Monitoring Report

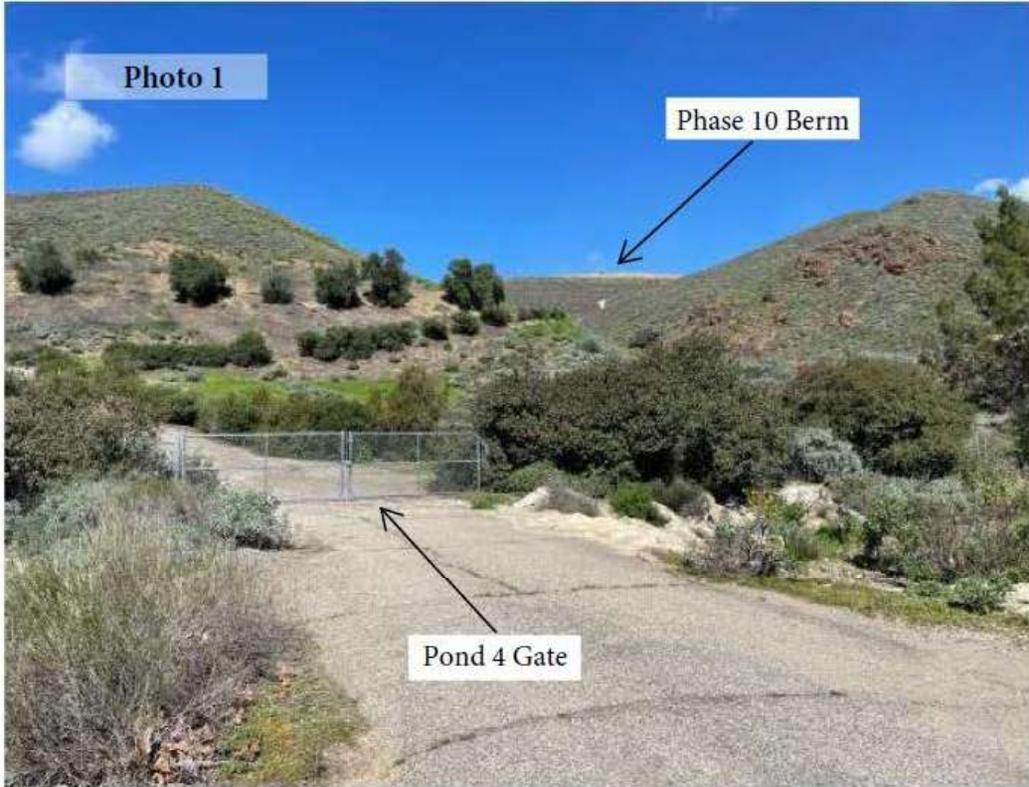
- Pond 4 visual inspection:
  - Pond 4 gate and fencing - good condition, no litter (photo 1).
  - Pond 4 outside slope - good vegetative cover.
  - Green table was observed with damaged conditions on the day of the assessment. Since then, the table has been replaced (photo 2).

- Berm 10/11:
  - No visible litter, good vegetative cover (photo 1 - Berm 10; photo 4 - Berm 11).
- Landfill operations:
  - Not visible from Dawson Canyon area or Spanish Hills/Trilogy area.

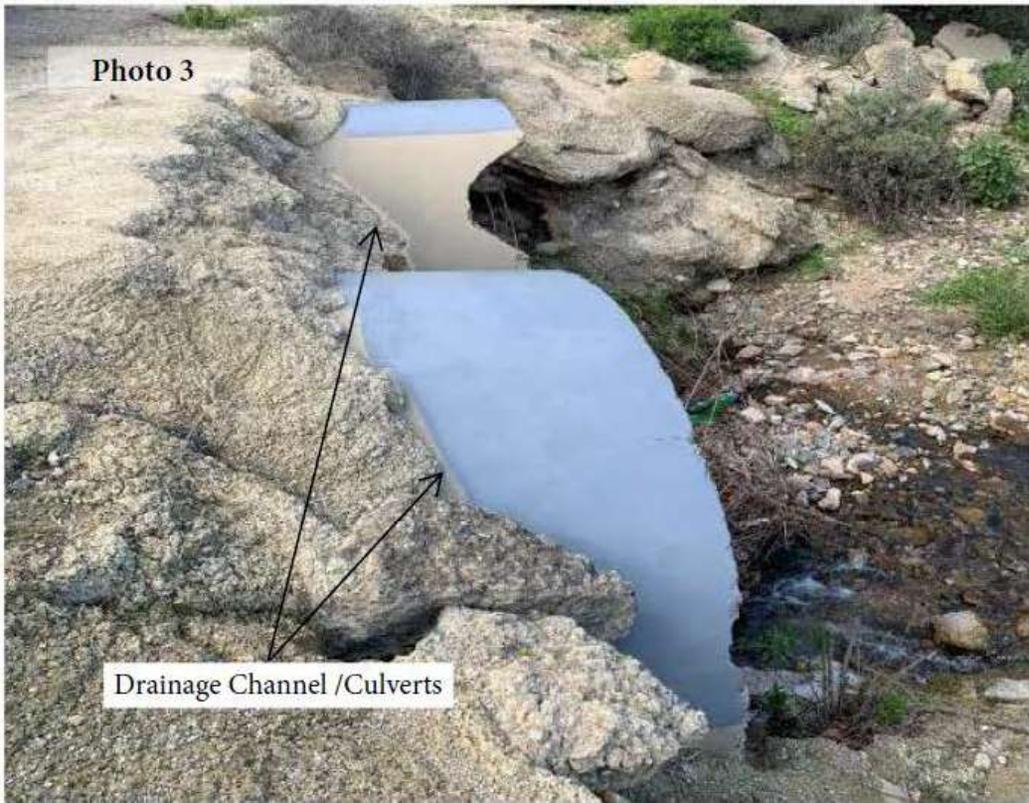
- Drainage channel/culverts:
  - Vegetation growth in the drainage channel east of the Pond 4 gate, but does not cause major debris or blockage.
  - Culvert chipping and graffiti was observed on the day of the assessment. Since then, the culverts have been painted (photo 3).

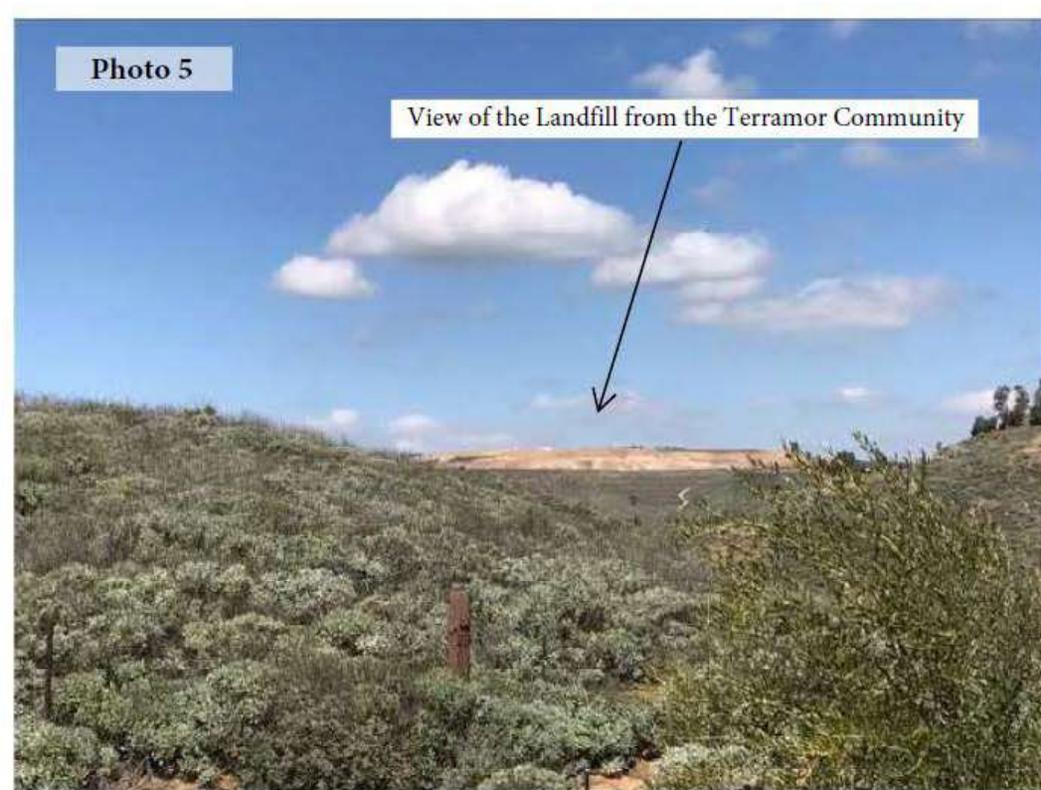
Photo 5

- No odor in Dawson Canyon (near Pond 4)
  - No odor in Spanish Hills/Trilogy area.
  - No odor in the Terramor Community. Landfill operations slightly visible from the Terramor Community, located south of the Landfill (photo 5).

View of the Landfill from the Terramor Community

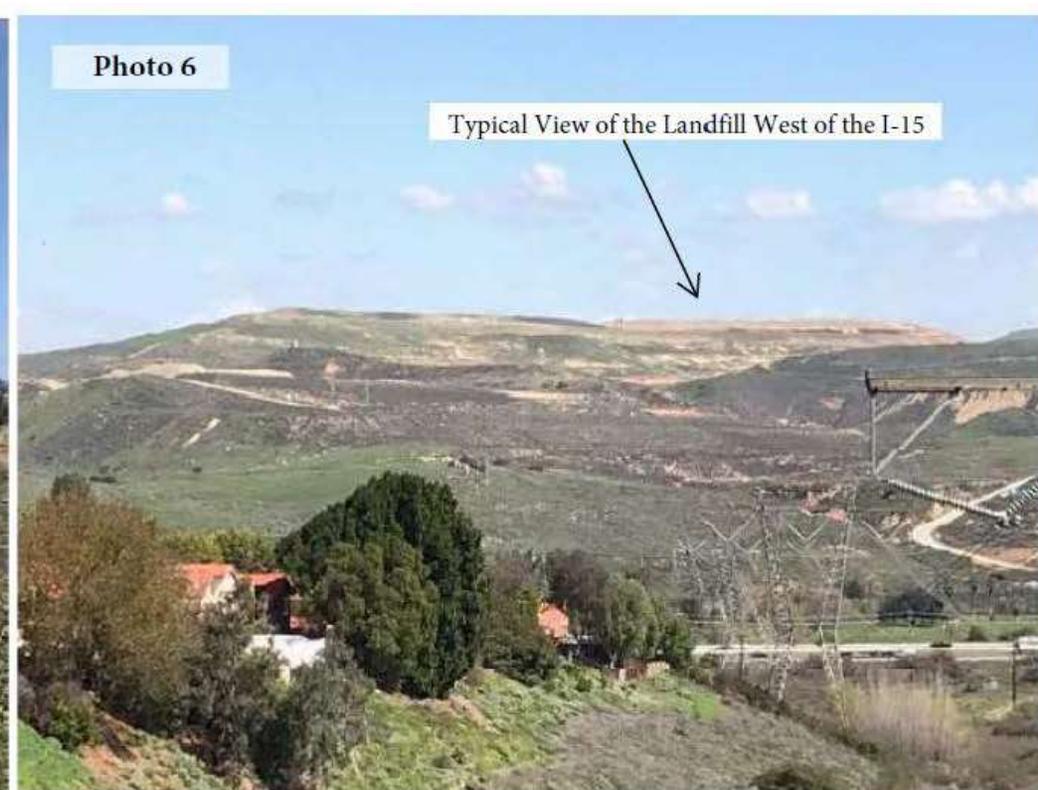
Photo 6

- Landfill operations not visible from communities west of I-15 (photos 6 and 7); bare outside slopes; USA Waste/WMI implementing plan to address the bare slopes.

Typical View of the Landfill West of the I-15

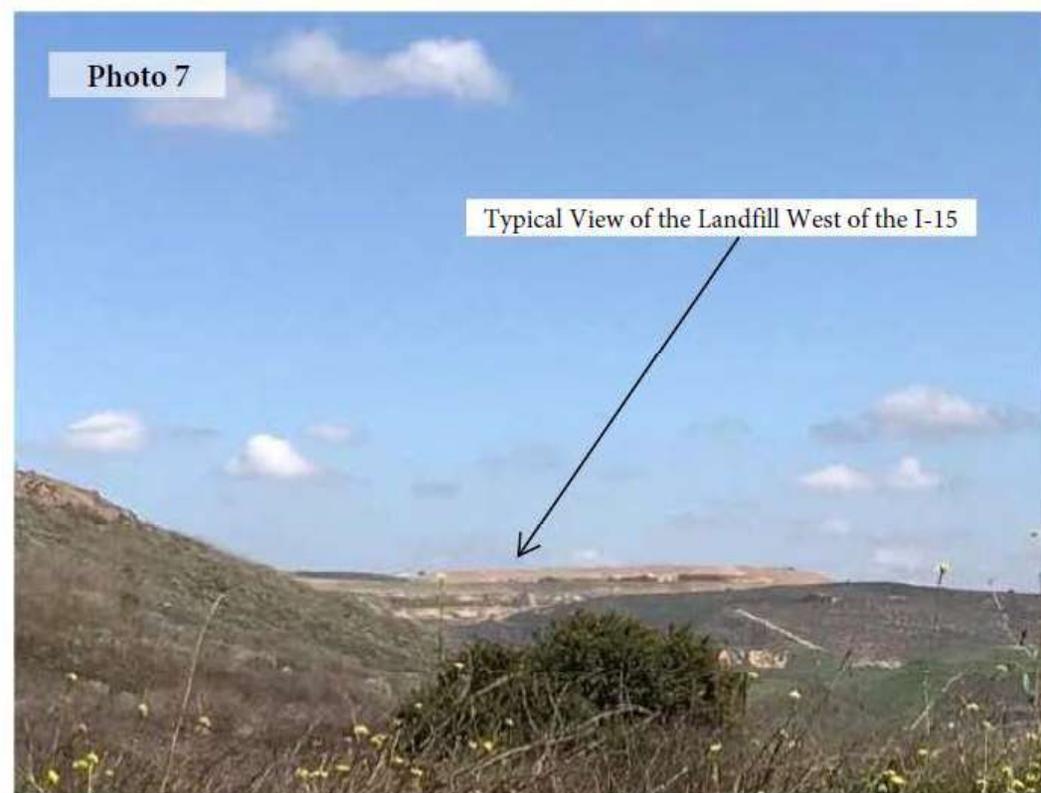
Photo 7

Typical View of the Landfill West of the I-15

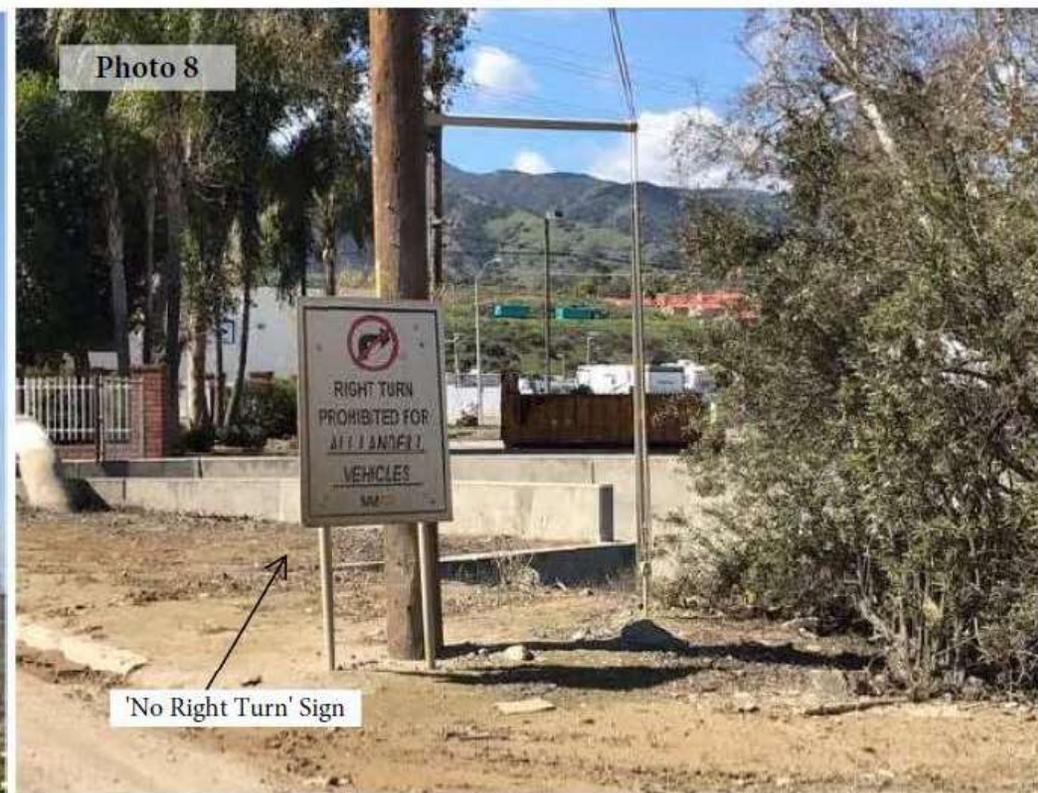
Photo 8

- 'No Right Turn' on Temescal Canyon Road (TCR) from Dawson Canyon:
  - No violations observed. No illegal right turns made by landfill trucks.
  - 'No Right Turn' sign is fully visible and in good condition (photo 8).

'No Right Turn' Sign

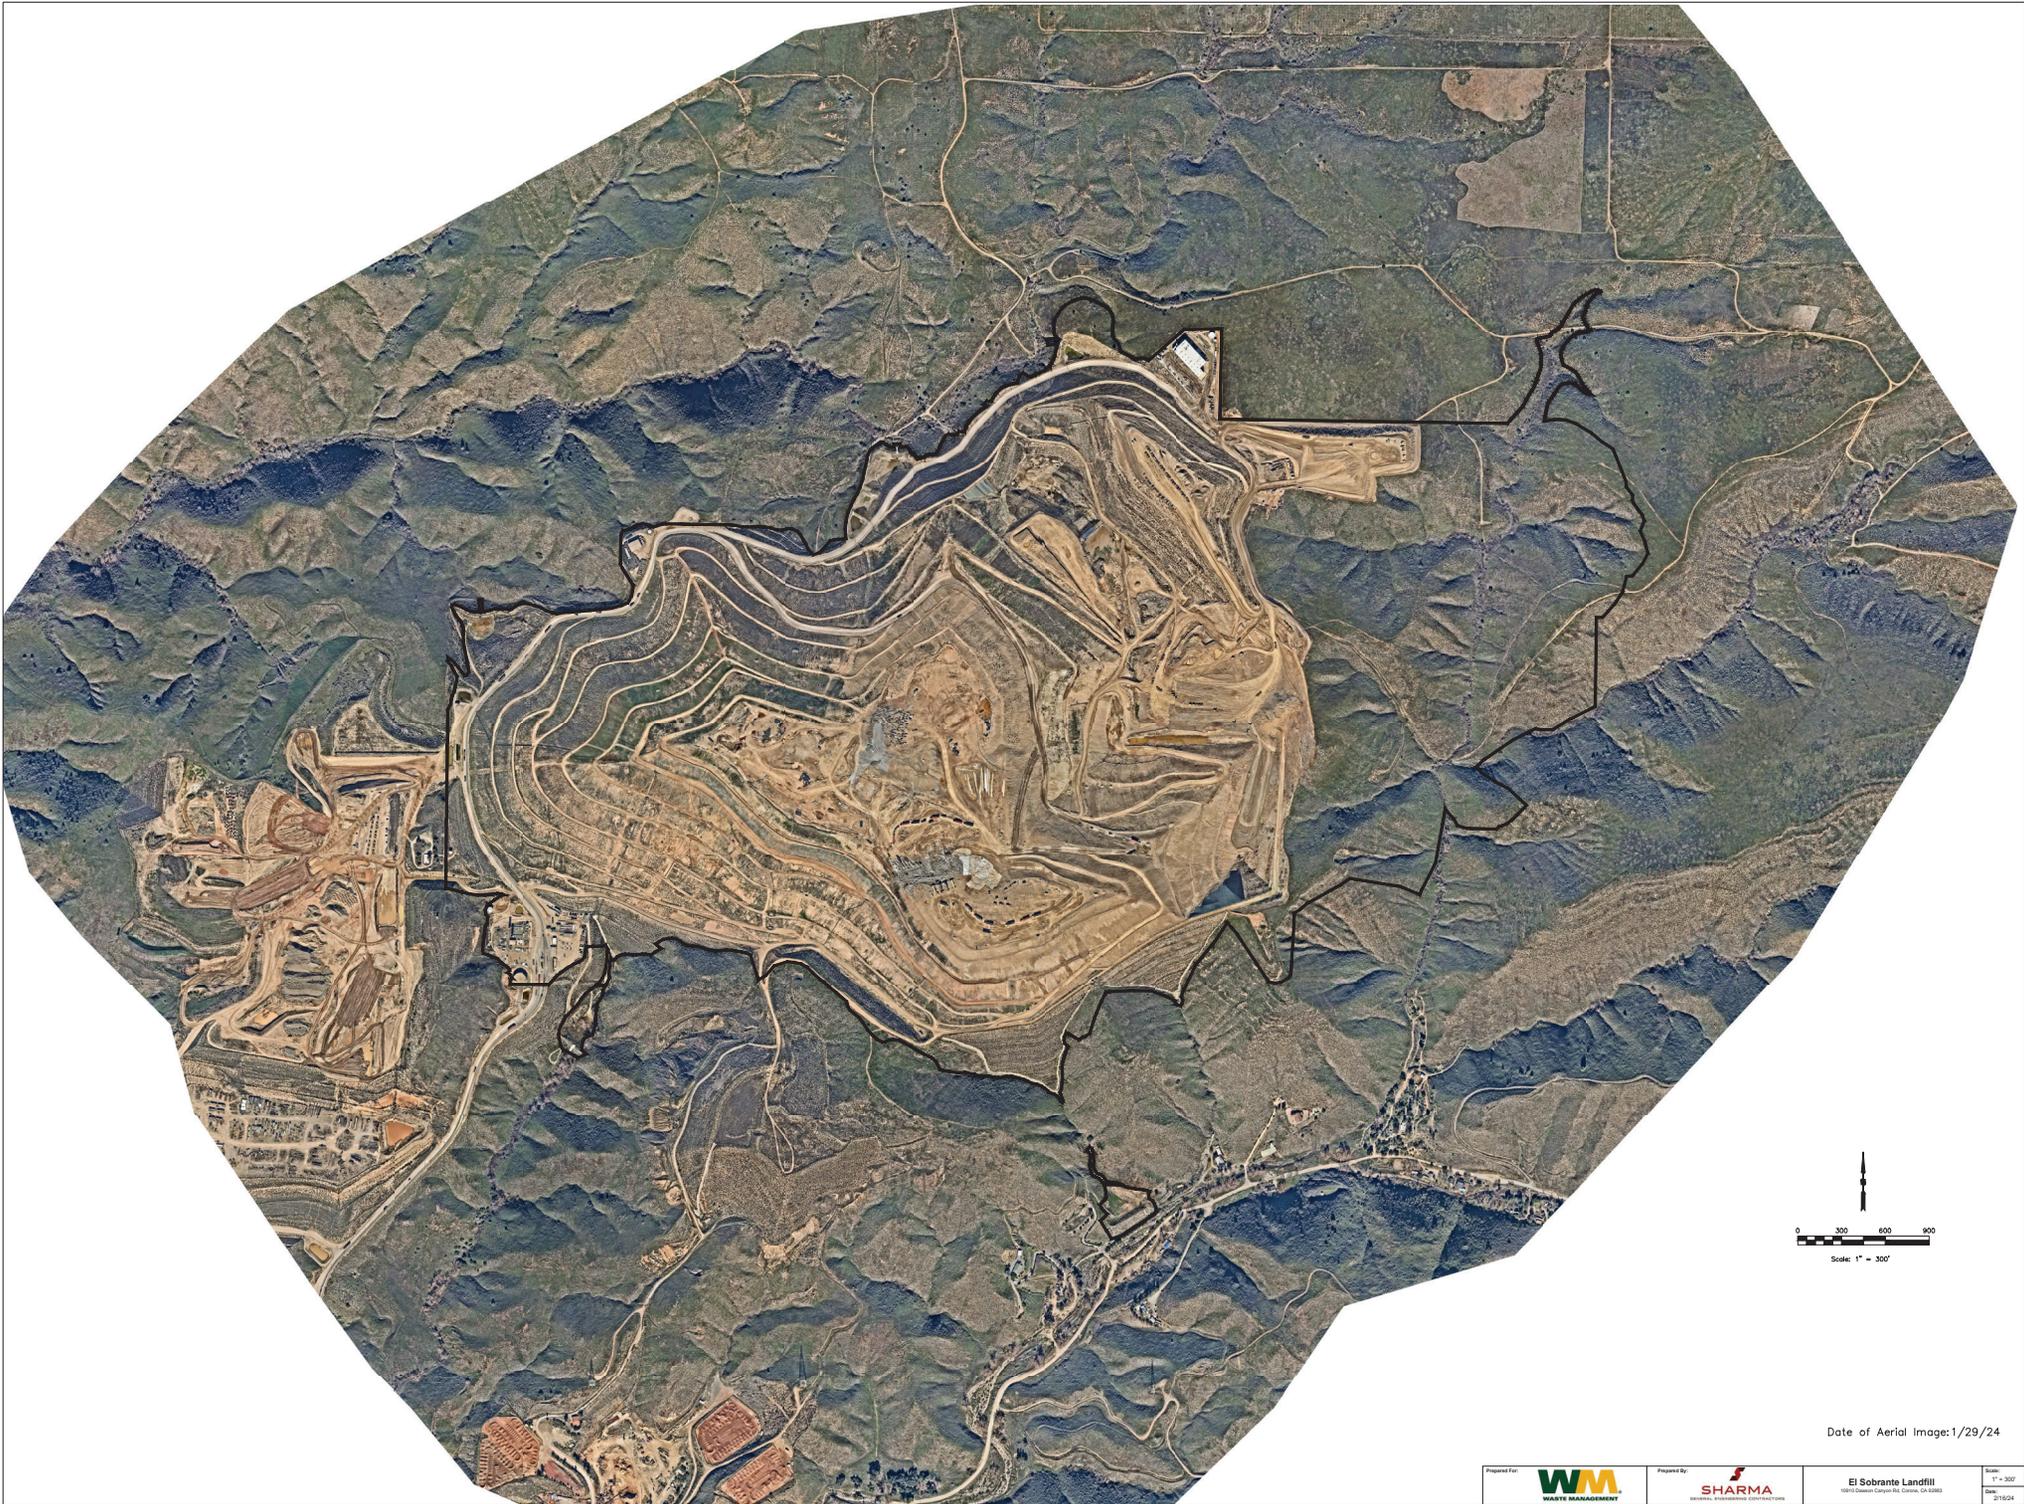
Date of Aerial Image: 1/29/24

- An updated aerial was taken on January 29, 2024 and showed no areas of offsite grading or operations.
