El Sobrante Landfill: Community Assessment

Date: September 17, 2024 Arrival time: 11:00 am Prepared by: Katherine Avila/Kinika Hesterly, RCDWR

El Sobrante Landfill Quarterly Mitigation Monitoring Report

Disposal Facility (Site) Inspection Report (52)
El Sobrante Landfill (33-AA-0217)
7/3/2024

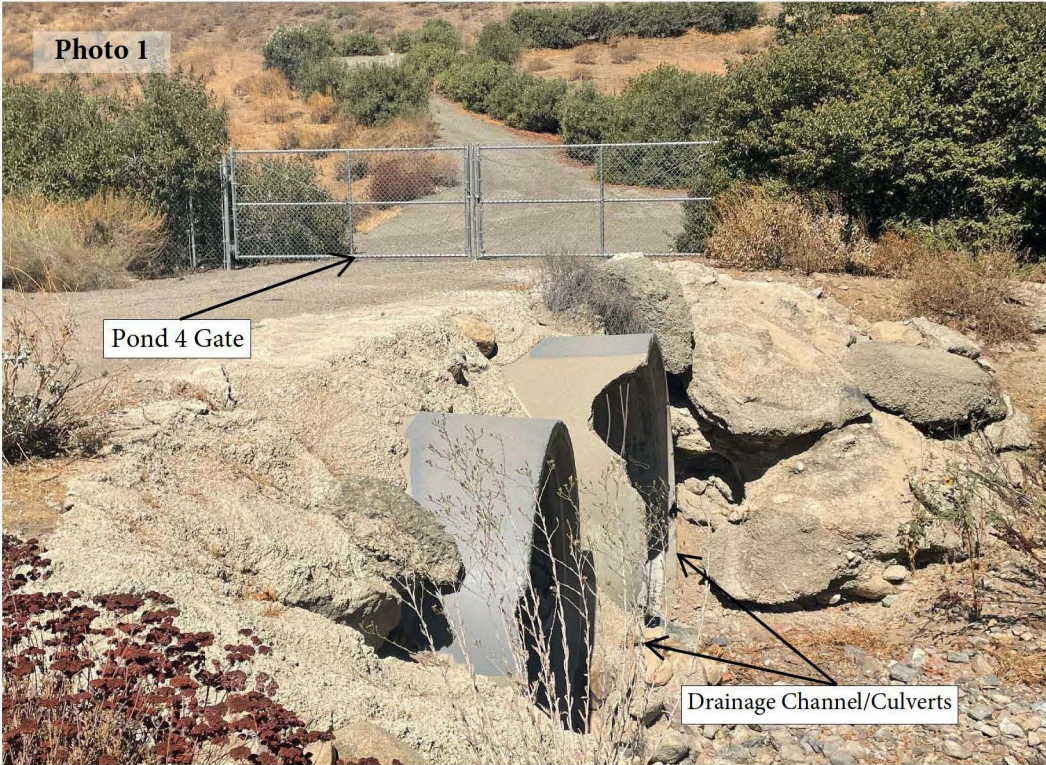
Photo 1

- Pond 4 visual inspection:
 - Pond 4 gate and fencing - good condition, no litter (photo 1).
 - Pond 4 outside slope - good vegetative cover.
 - Green park table and bench - good condition (photo 2).

- Drainage channel/culverts:
 - No blockage observed in the drainage channel east or west of the Pond 4 gate.
 - Culvert chipping was observed; no new signs of graffiti (photo 1).

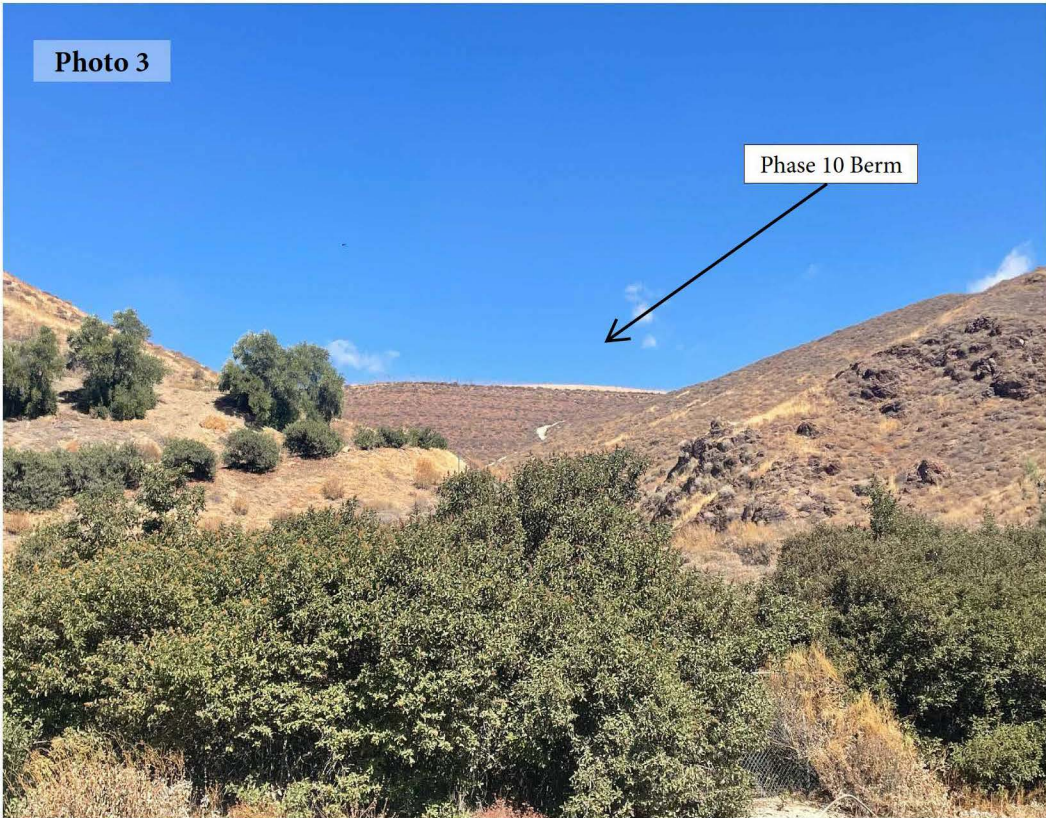
Photo 3

- Berm 10/11:
 - No visible litter, good vegetative cover (photo 3 - Berm 10; photo 4 - Berm 11).
- Landfill operations:
 - Not visible from Dawson Canyon area or Spanish Hills/Trilogy area.

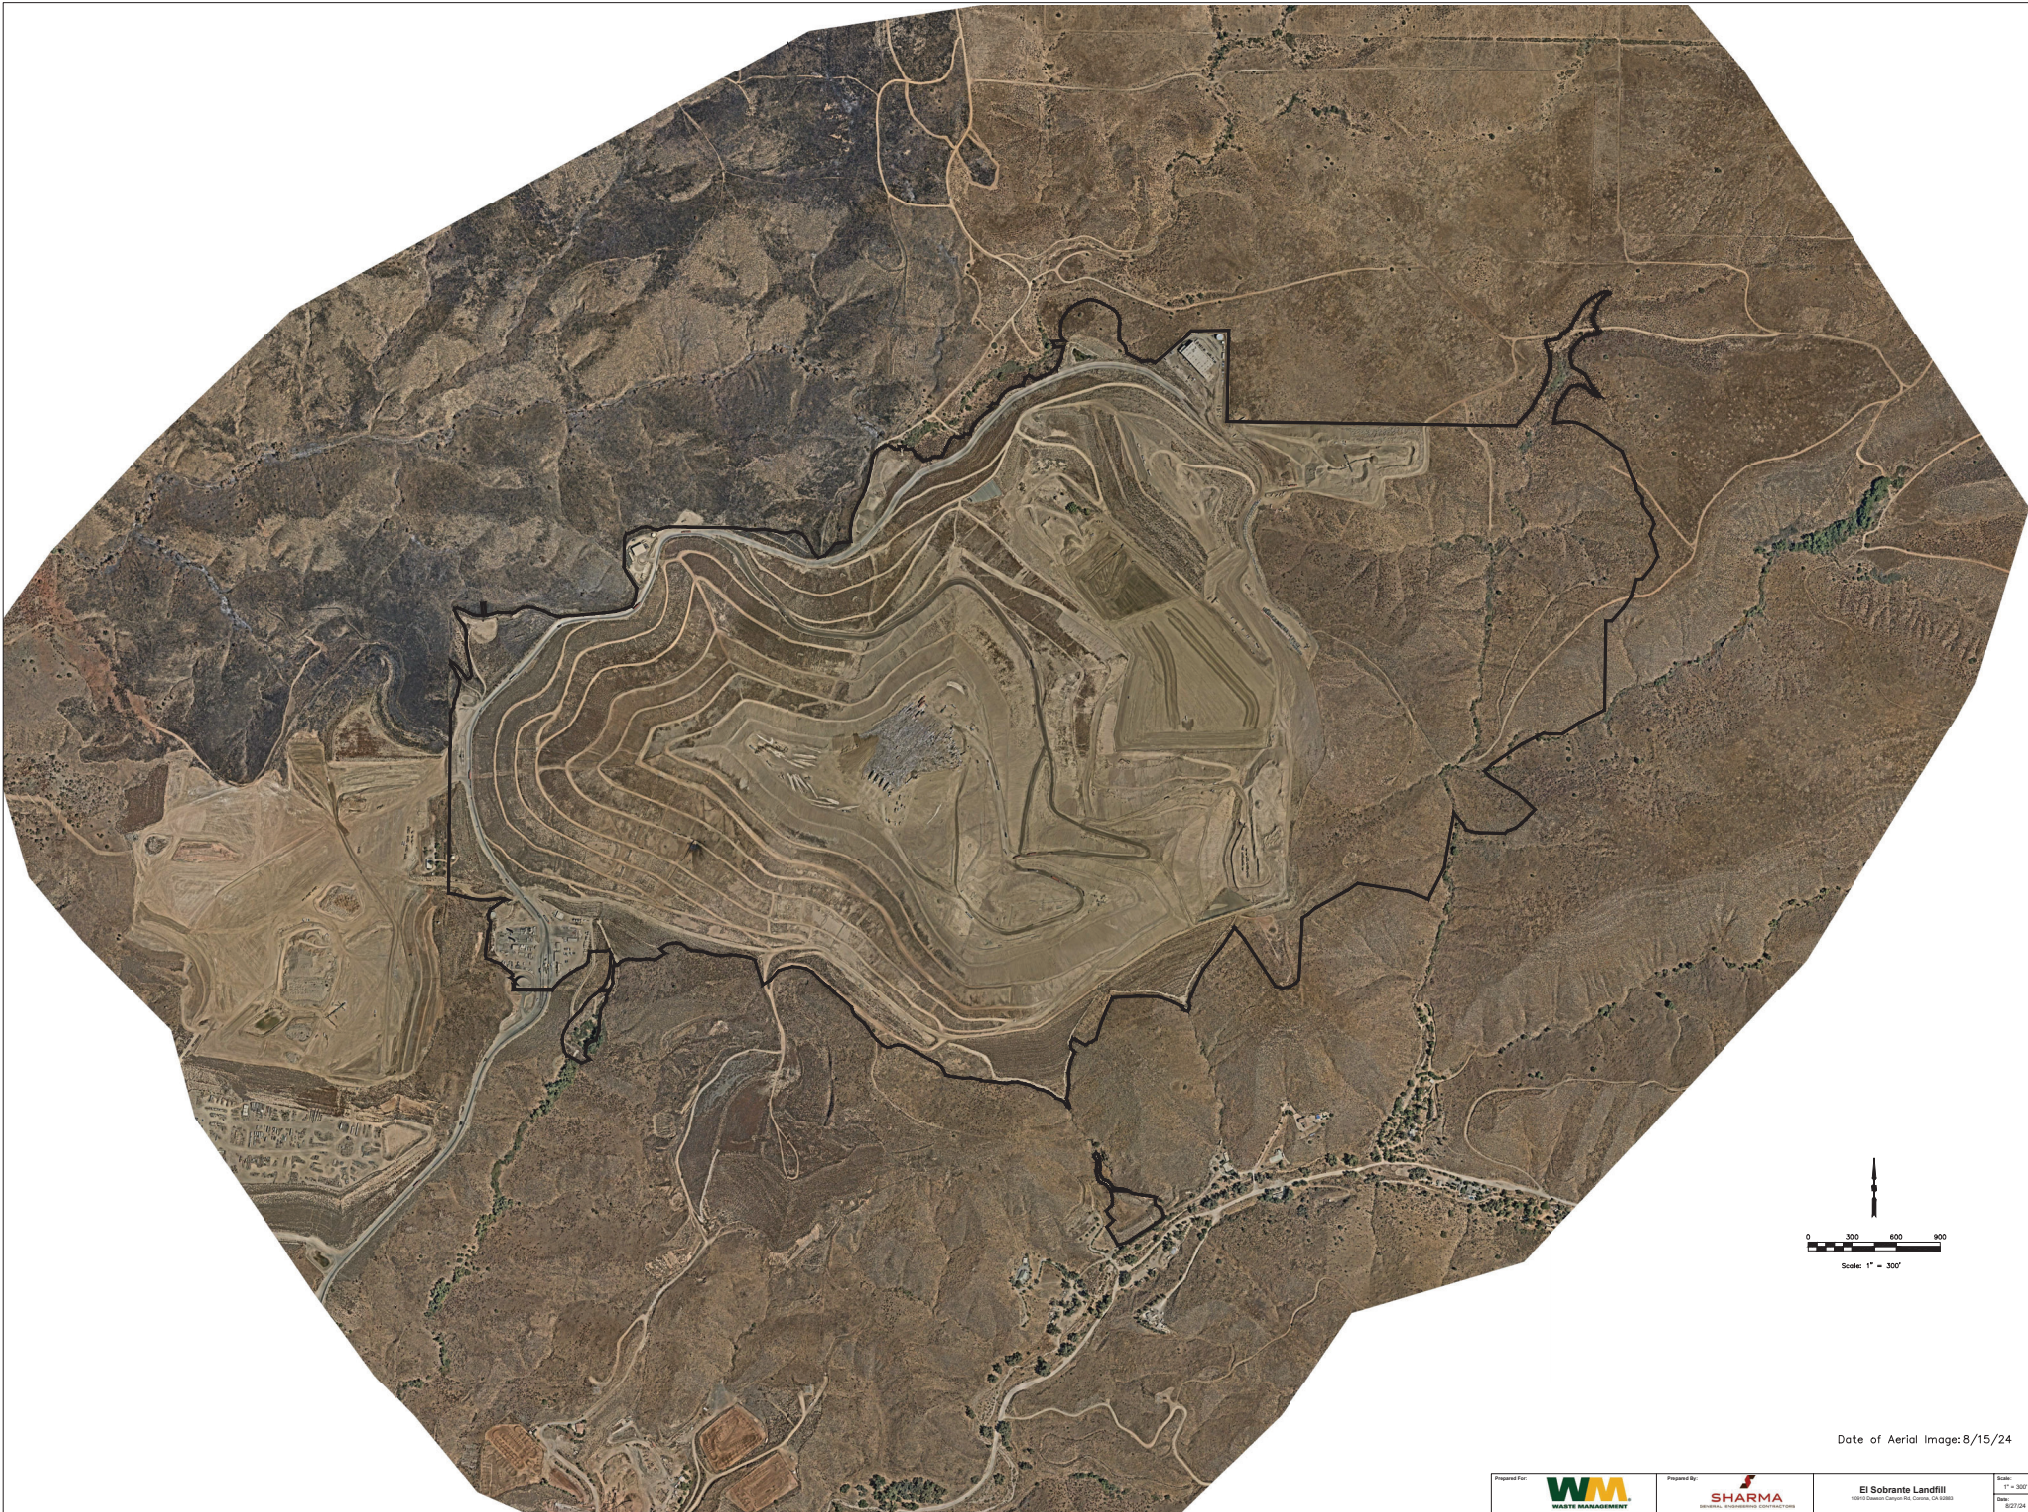
Photo 8

- 'No Right Turn' on Temescal Canyon Road (TCR) from Dawson Canyon:
 - No violations observed. No illegal right turns made by landfill trucks.
 - 'No Right Turn' sign is fully visible (photo 8).

'No Right Turn' Sign
