## Community Assessment

## El Sobrante Landfill: Community Assessment

Date: March 18 & 25, 2026 Arrival time: 10:00 am Prepared by: Katherine Veliz/Aliah Mitchell/Kinika Hesterly, RCDWR

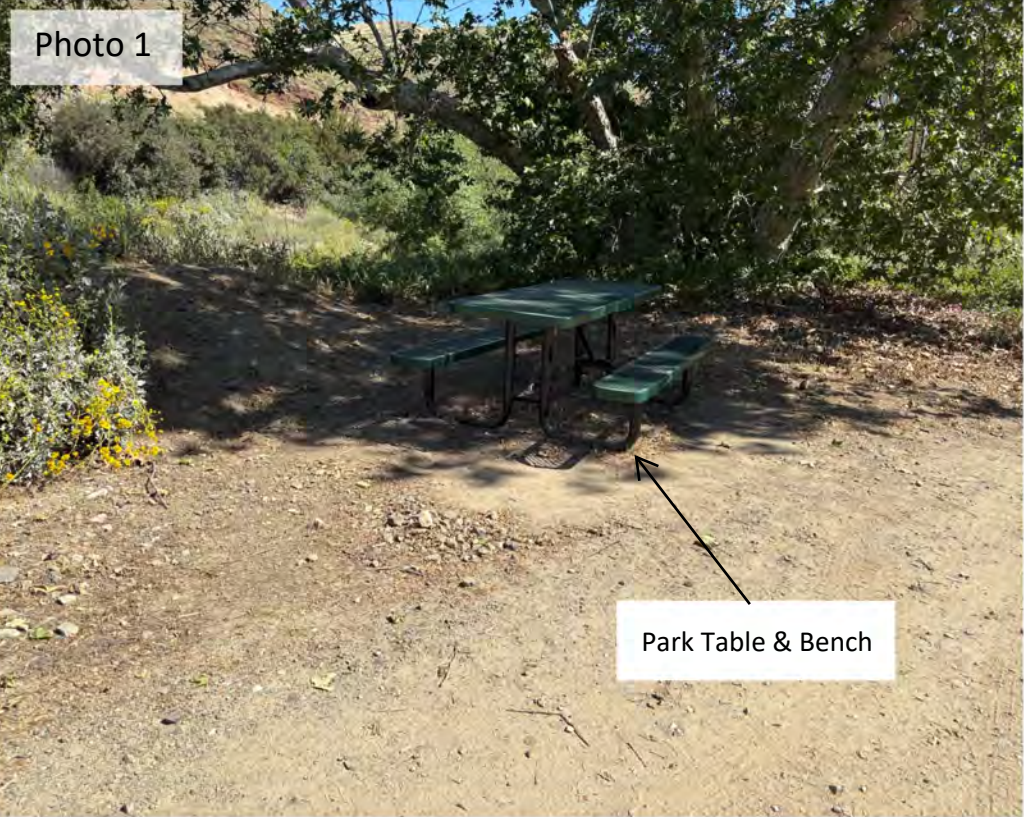
Photo 1

- Pond 4 visual inspection:
  - Green park table and bench - good condition (photo 1).
  - Pond 4 gate and fencing - good condition, no litter (photo 2).

Park Table & Bench

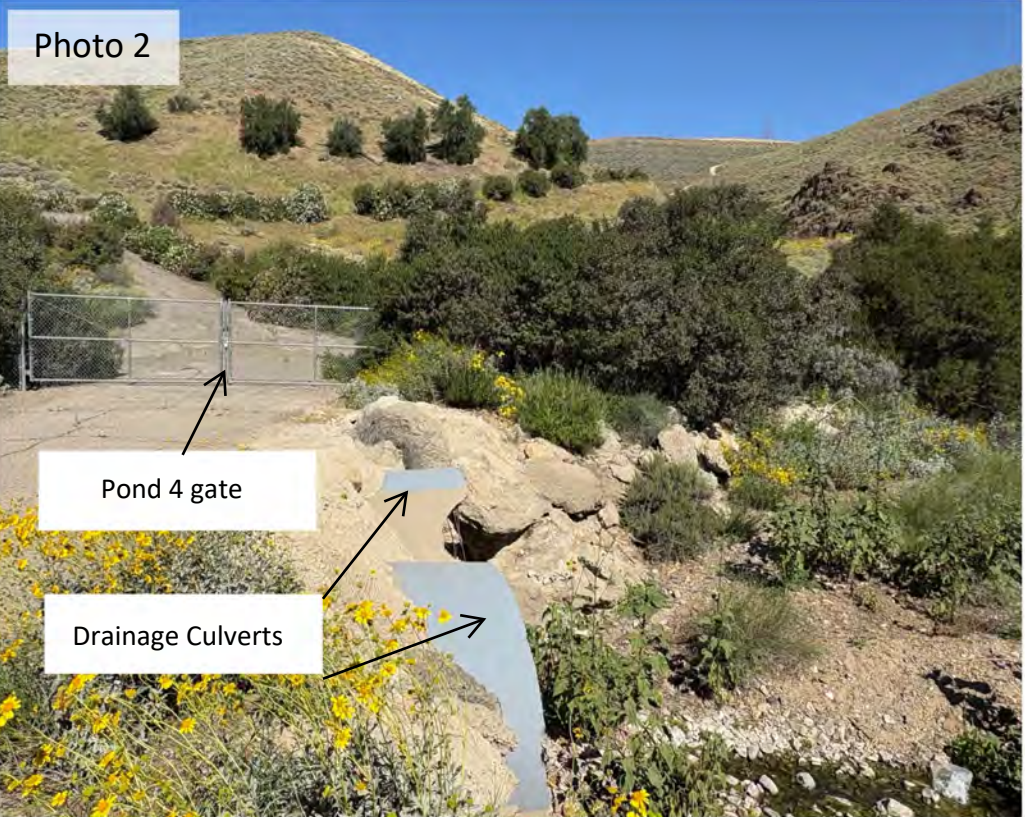
Photo 2

- Culvert chipping was observed; no signs of graffiti (photo 2).
- Dawson Canyon Road condition:
  - The dirt section subject to quarterly grading by WM was smooth with even surfaces. The road was graded in the 1<sup>st</sup> quarter on March 18, 2026.

Pond 4 gate

Drainage Culverts

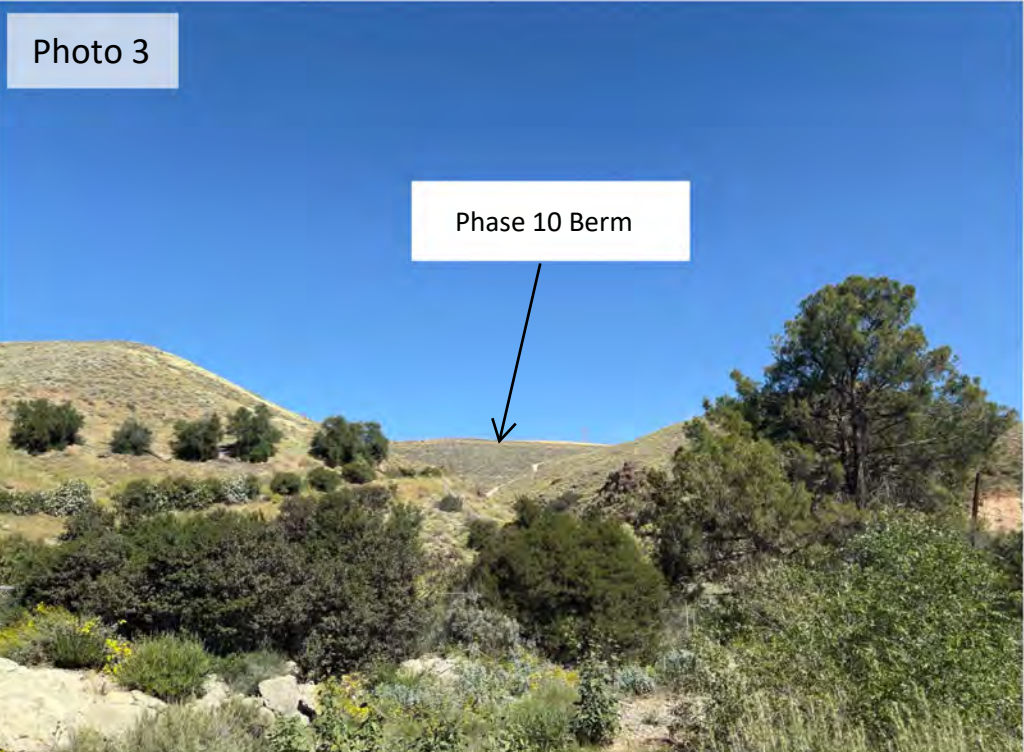
Photo 3

- Berm 10/11:
  - No visible litter, good vegetative cover (photo 3 - Berm 10; photo 4 - Berm 11).
- Landfill operations:
  - Not visible from Dawson Canyon area or Spanish Hills/Trilogy area.

Phase 10 Berm

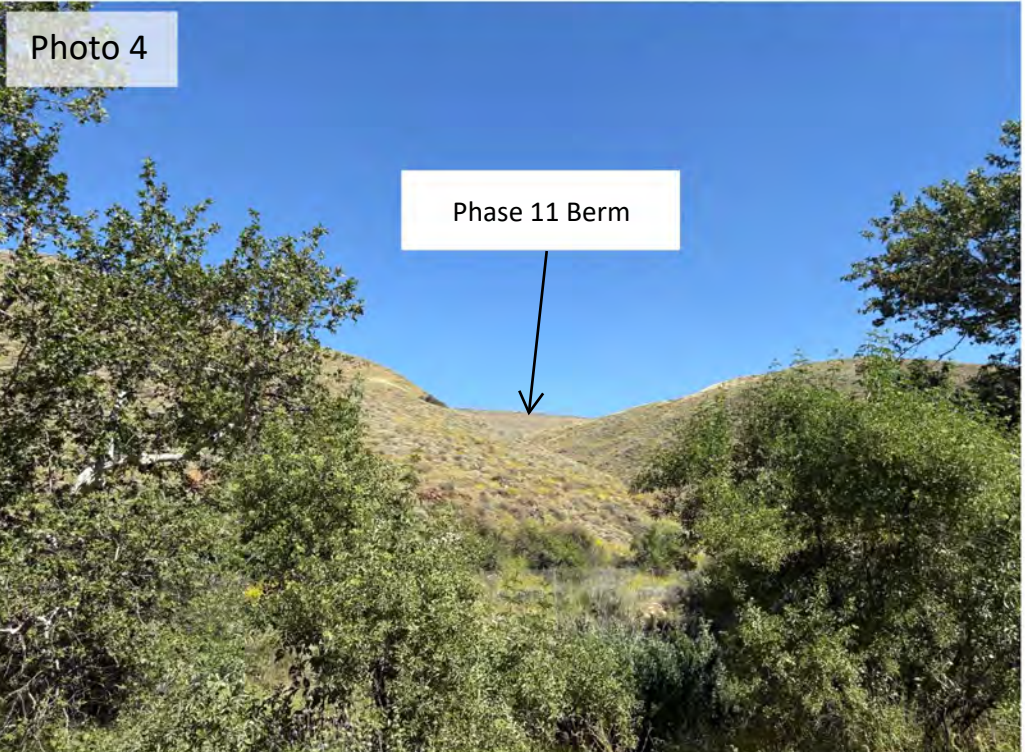
Photo 4

Phase 11 Berm

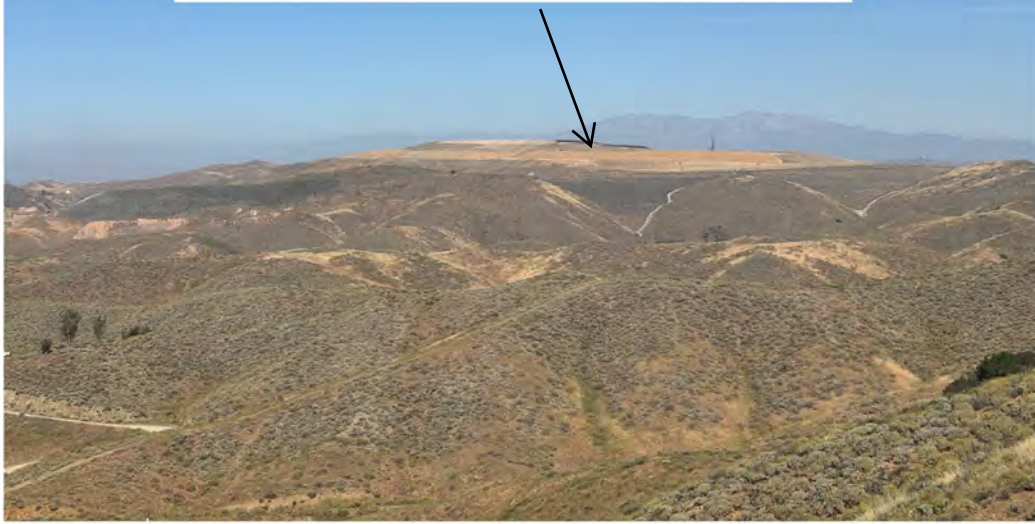
Photo 5

- Landfill operations not visible from the Terramor Community (photo 5).
  - No new noticeable erosion on landfill slopes visible from the communities.

Typical View from Terramor Community

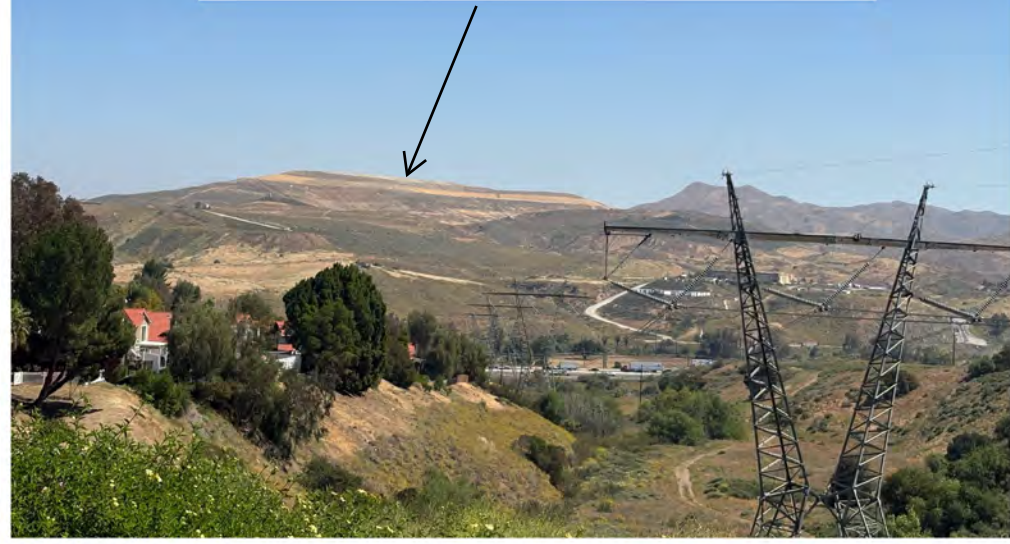
Photo 6

Typical View from Trilogy Community West of I-15

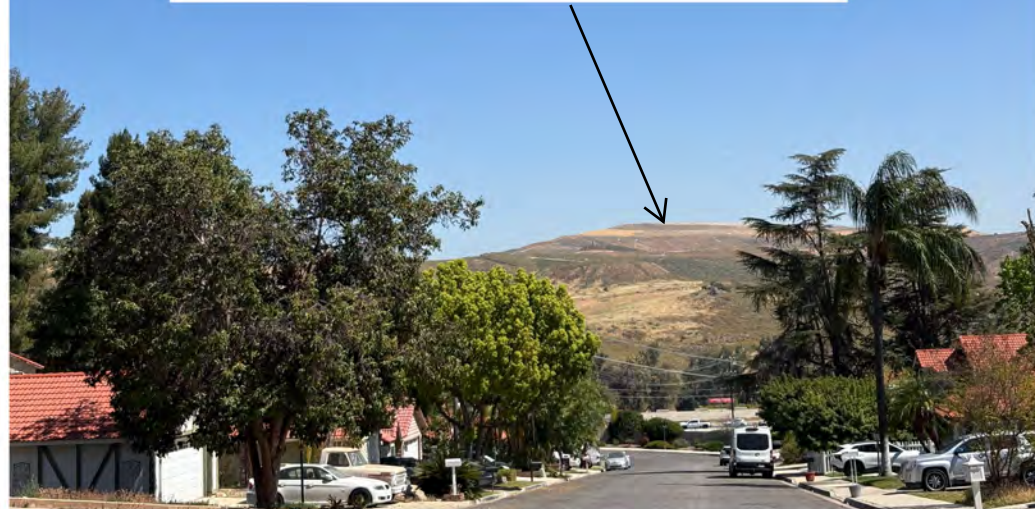
Photo 7

Typical View from Trilogy Community West of I-15

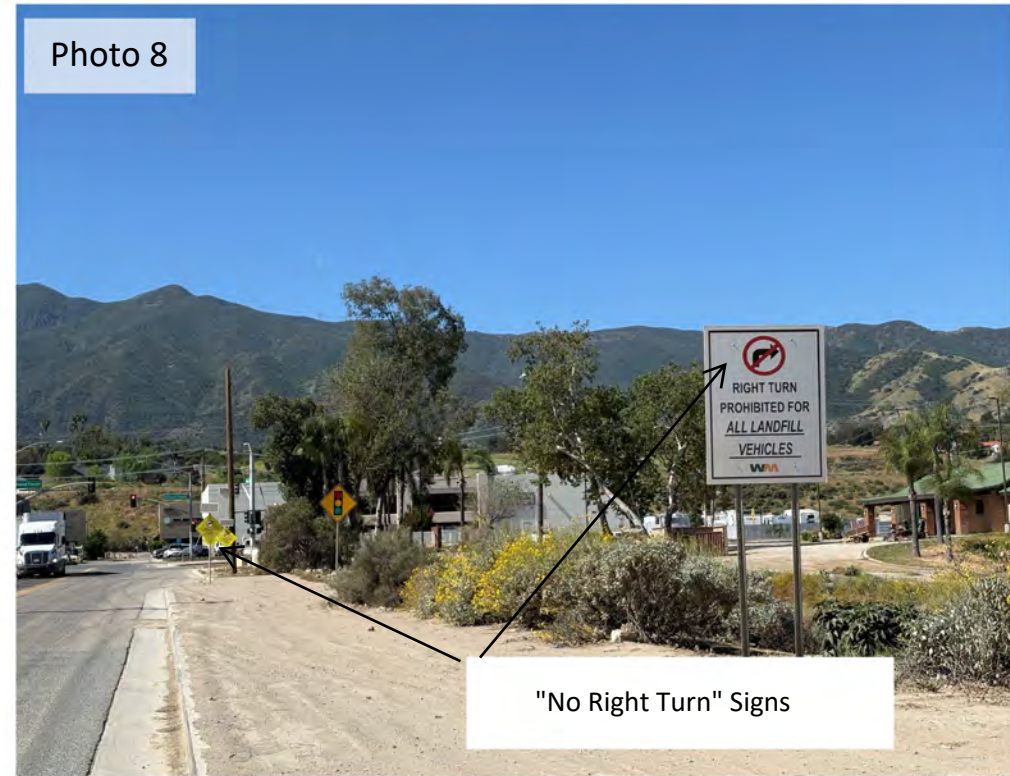
Photo 8

- 'No Right Turn' on Temescal Canyon Road (TCR) from Dawson Canyon:
  - No violations observed. No illegal right turns made by landfill trucks.
  - 'No Right Turn' signs are fully visible (photo 8), including 3 new neon flashing signs stating 'Right Turn Prohibited For All Landfill Vehicles'.

"No Right Turn" Signs
