# El Sobrante Landfill Citizens Oversight Committee

2<sup>nd</sup> Quarter 2024

## **El Sobrante Landfill: Community Assessment**

Date: June 6, 2024    Arrival time: 10:00 am    Prepared by: Katherine Avila/Kinika Hesterly, RCDWR

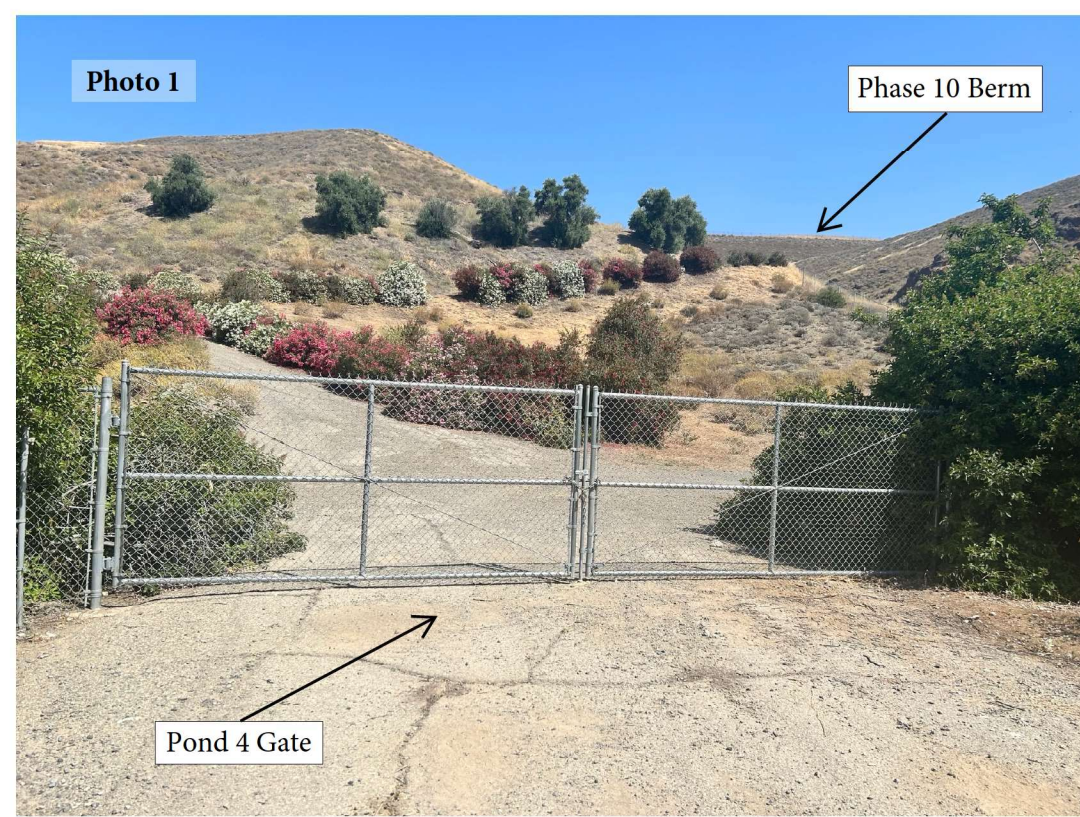
Photo 1

- Pond 4 visual inspection:
  - Pond 4 gate and fencing - good condition, no litter (photo 1).
  - Pond 4 outside slope - good vegetative cover.
  - Green park table and bench - good condition (photo 2).

- Berm 10/11:
  - No visible litter, good vegetative cover (photo 1 - Berm 10; photo 4 - Berm 11).
- Landfill operations:
  - Not visible from Dawson Canyon area or Spanish Hills/Trilogy area.

Phase 10 Berm

Pond 4 Gate

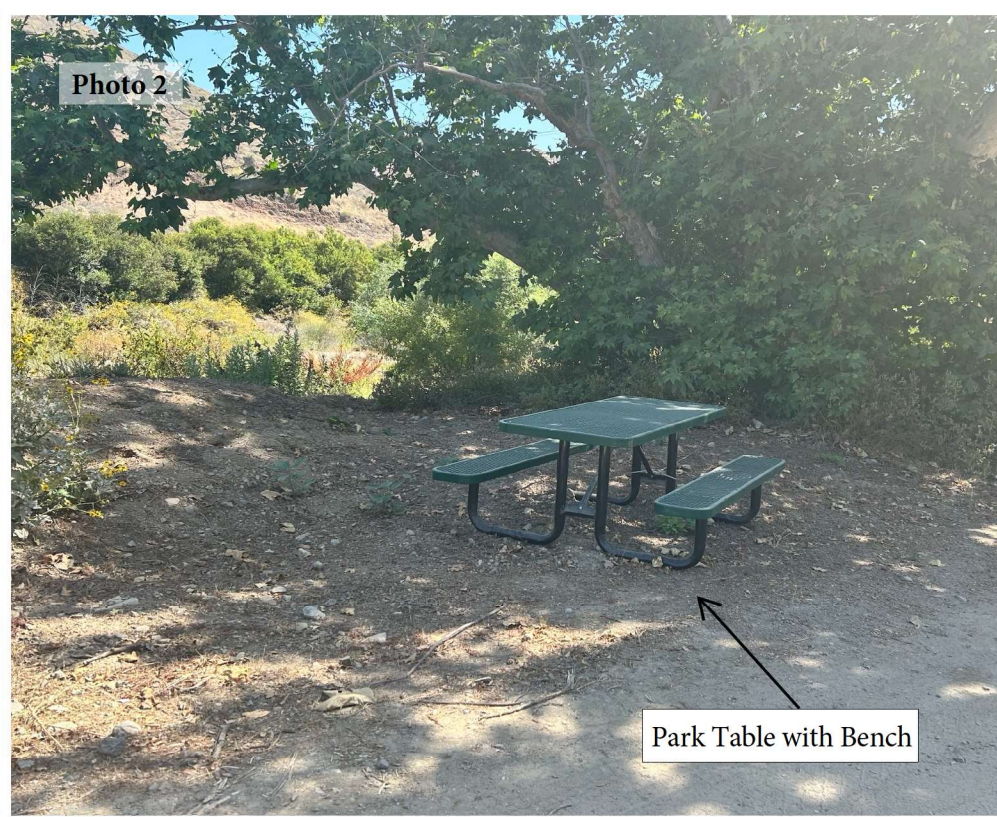
Photo 2

Park Table with Bench

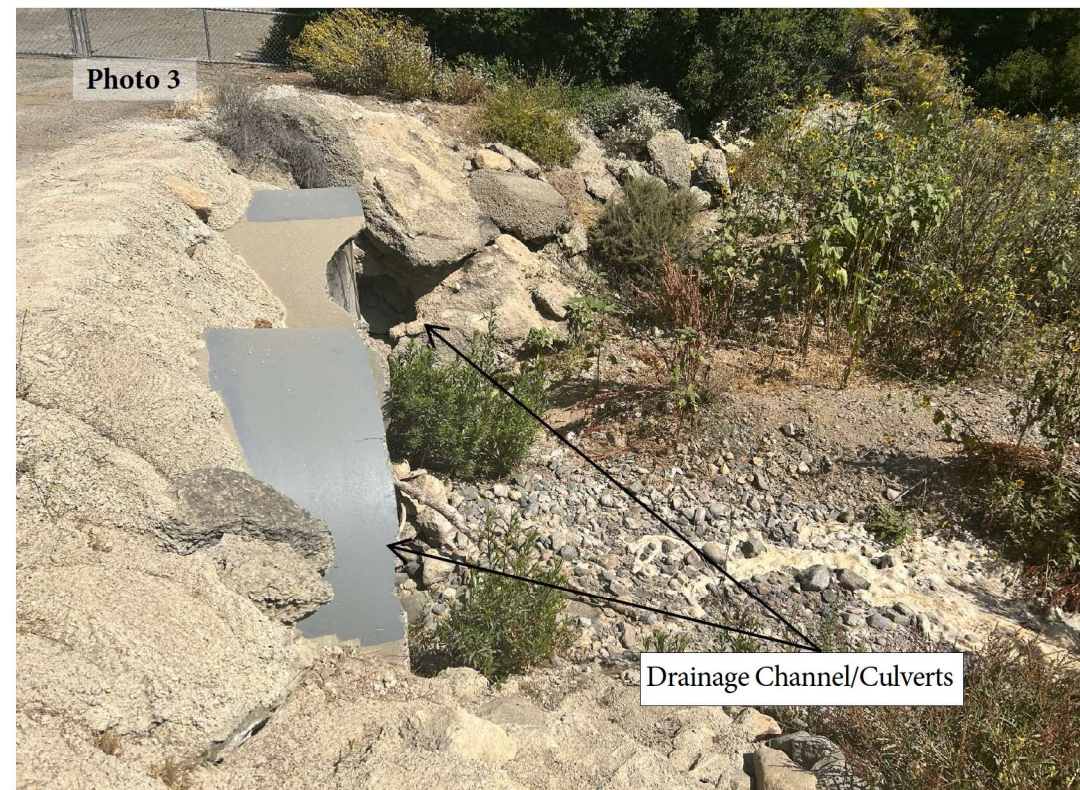
Photo 3

- Drainage channel/culverts:
  - Vegetation growth in the drainage channel east of the Pond 4 gate but does not cause major debris or blockage.
  - Culvert chipping was observed; no new signs of graffiti (photo 3).

Drainage Channel/Culverts

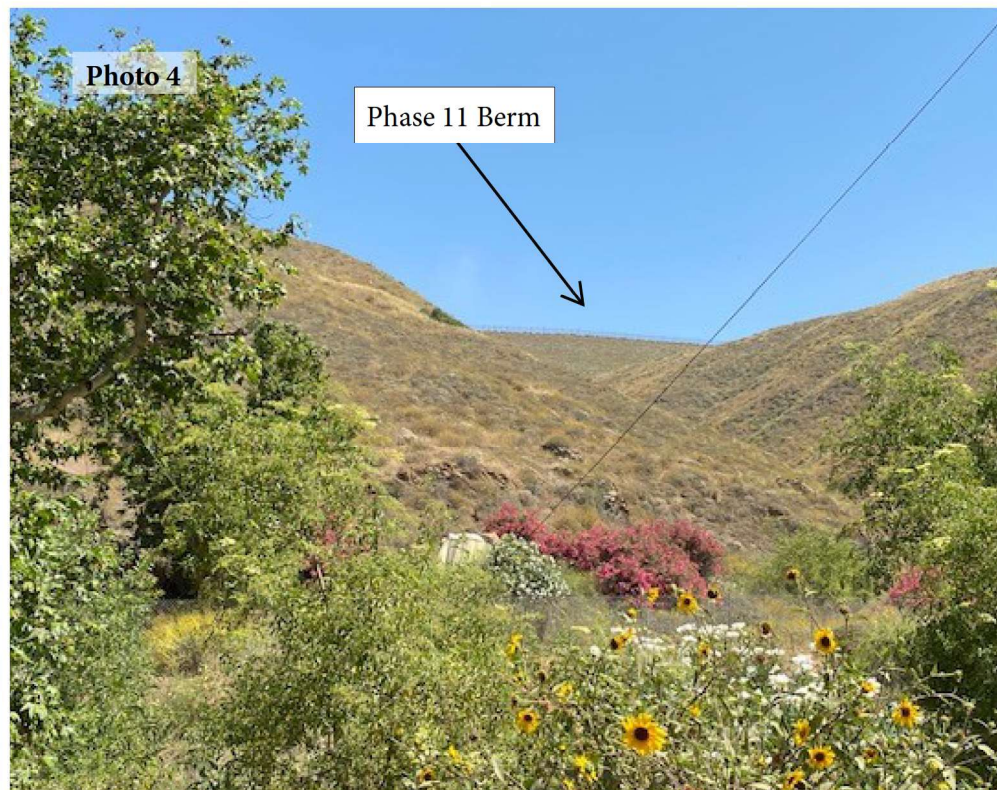
Photo 4

Phase 11 Berm

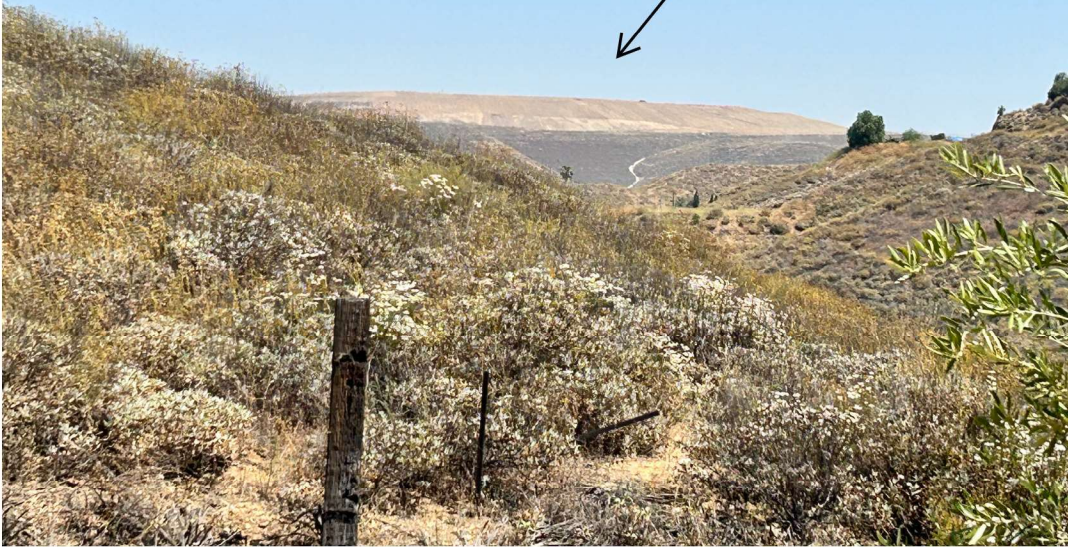
Photo 5

- No odor in Dawson Canyon (near Pond 4)
  - No odor in Spanish Hills/Trilogy area.
  - No odor in the Terramor Community. Landfill operations slightly visible from the Terramor Community, located south of the Landfill (photo 5).

View of the Landfill from the Terramor Community

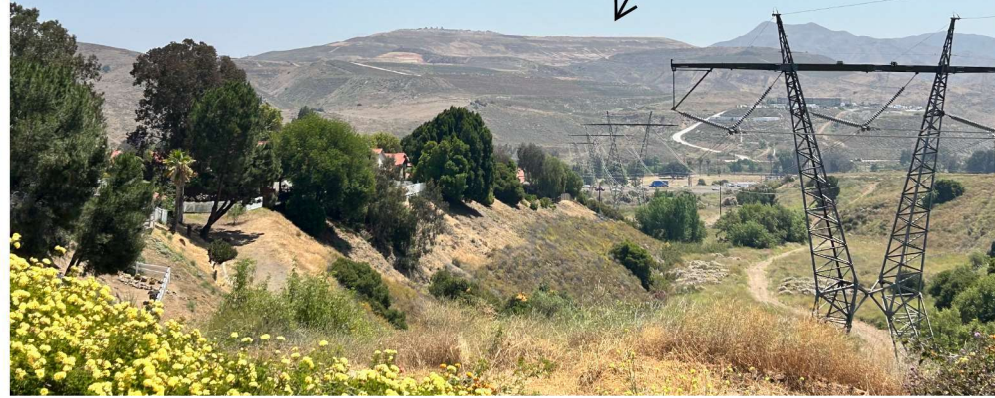
Photo 6

- Landfill operations not visible from communities west of I-15 (photos 6 and 7); bare outside slopes; USA Waste/WMI implementing plan to address the bare slopes.

View of the Landfill West of the I-15

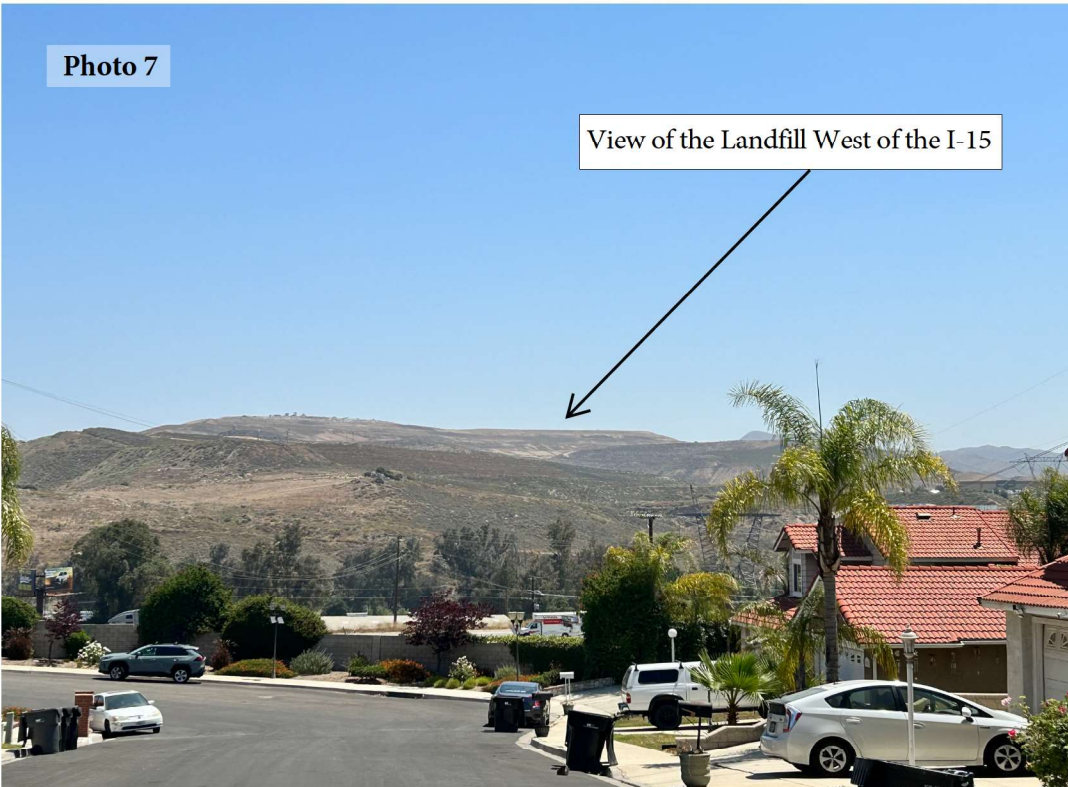
Photo 7

View of the Landfill West of the I-15

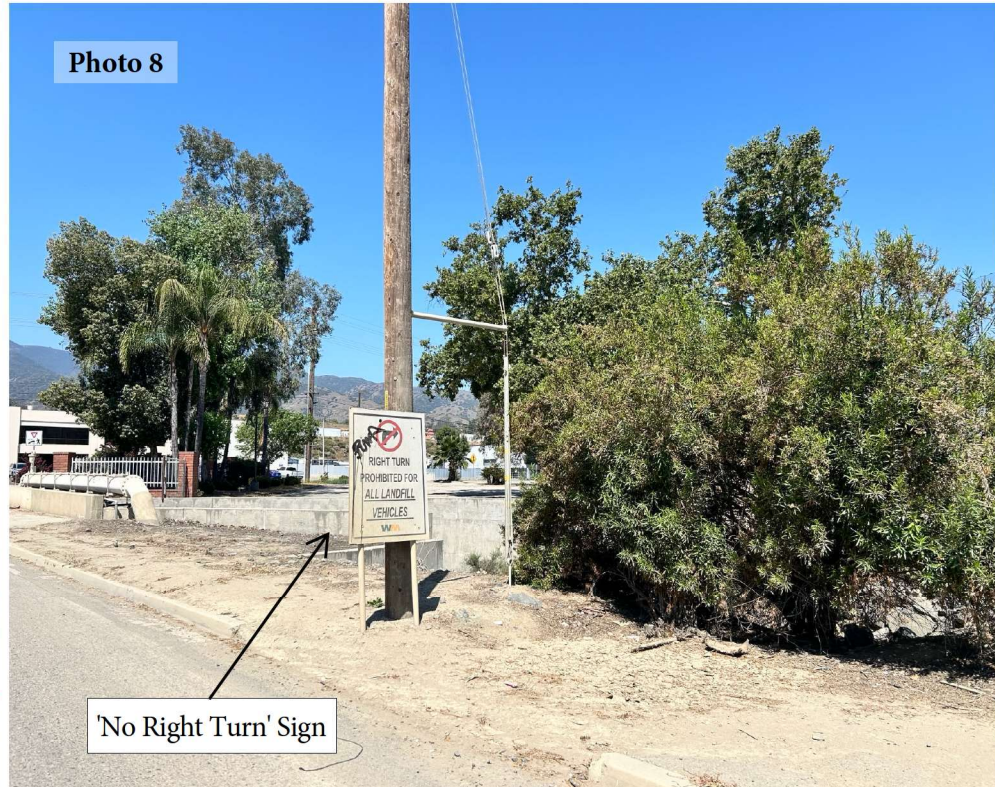
Photo 8

- 'No Right Turn' on Temescal Canyon Road (TCR) from Dawson Canyon:
  - No violations observed. No illegal right turns made by landfill trucks.
  - 'No Right Turn' sign is fully visible, however graffiti was observed on the top left corner of the sign (photo 8).

'No Right Turn' Sign

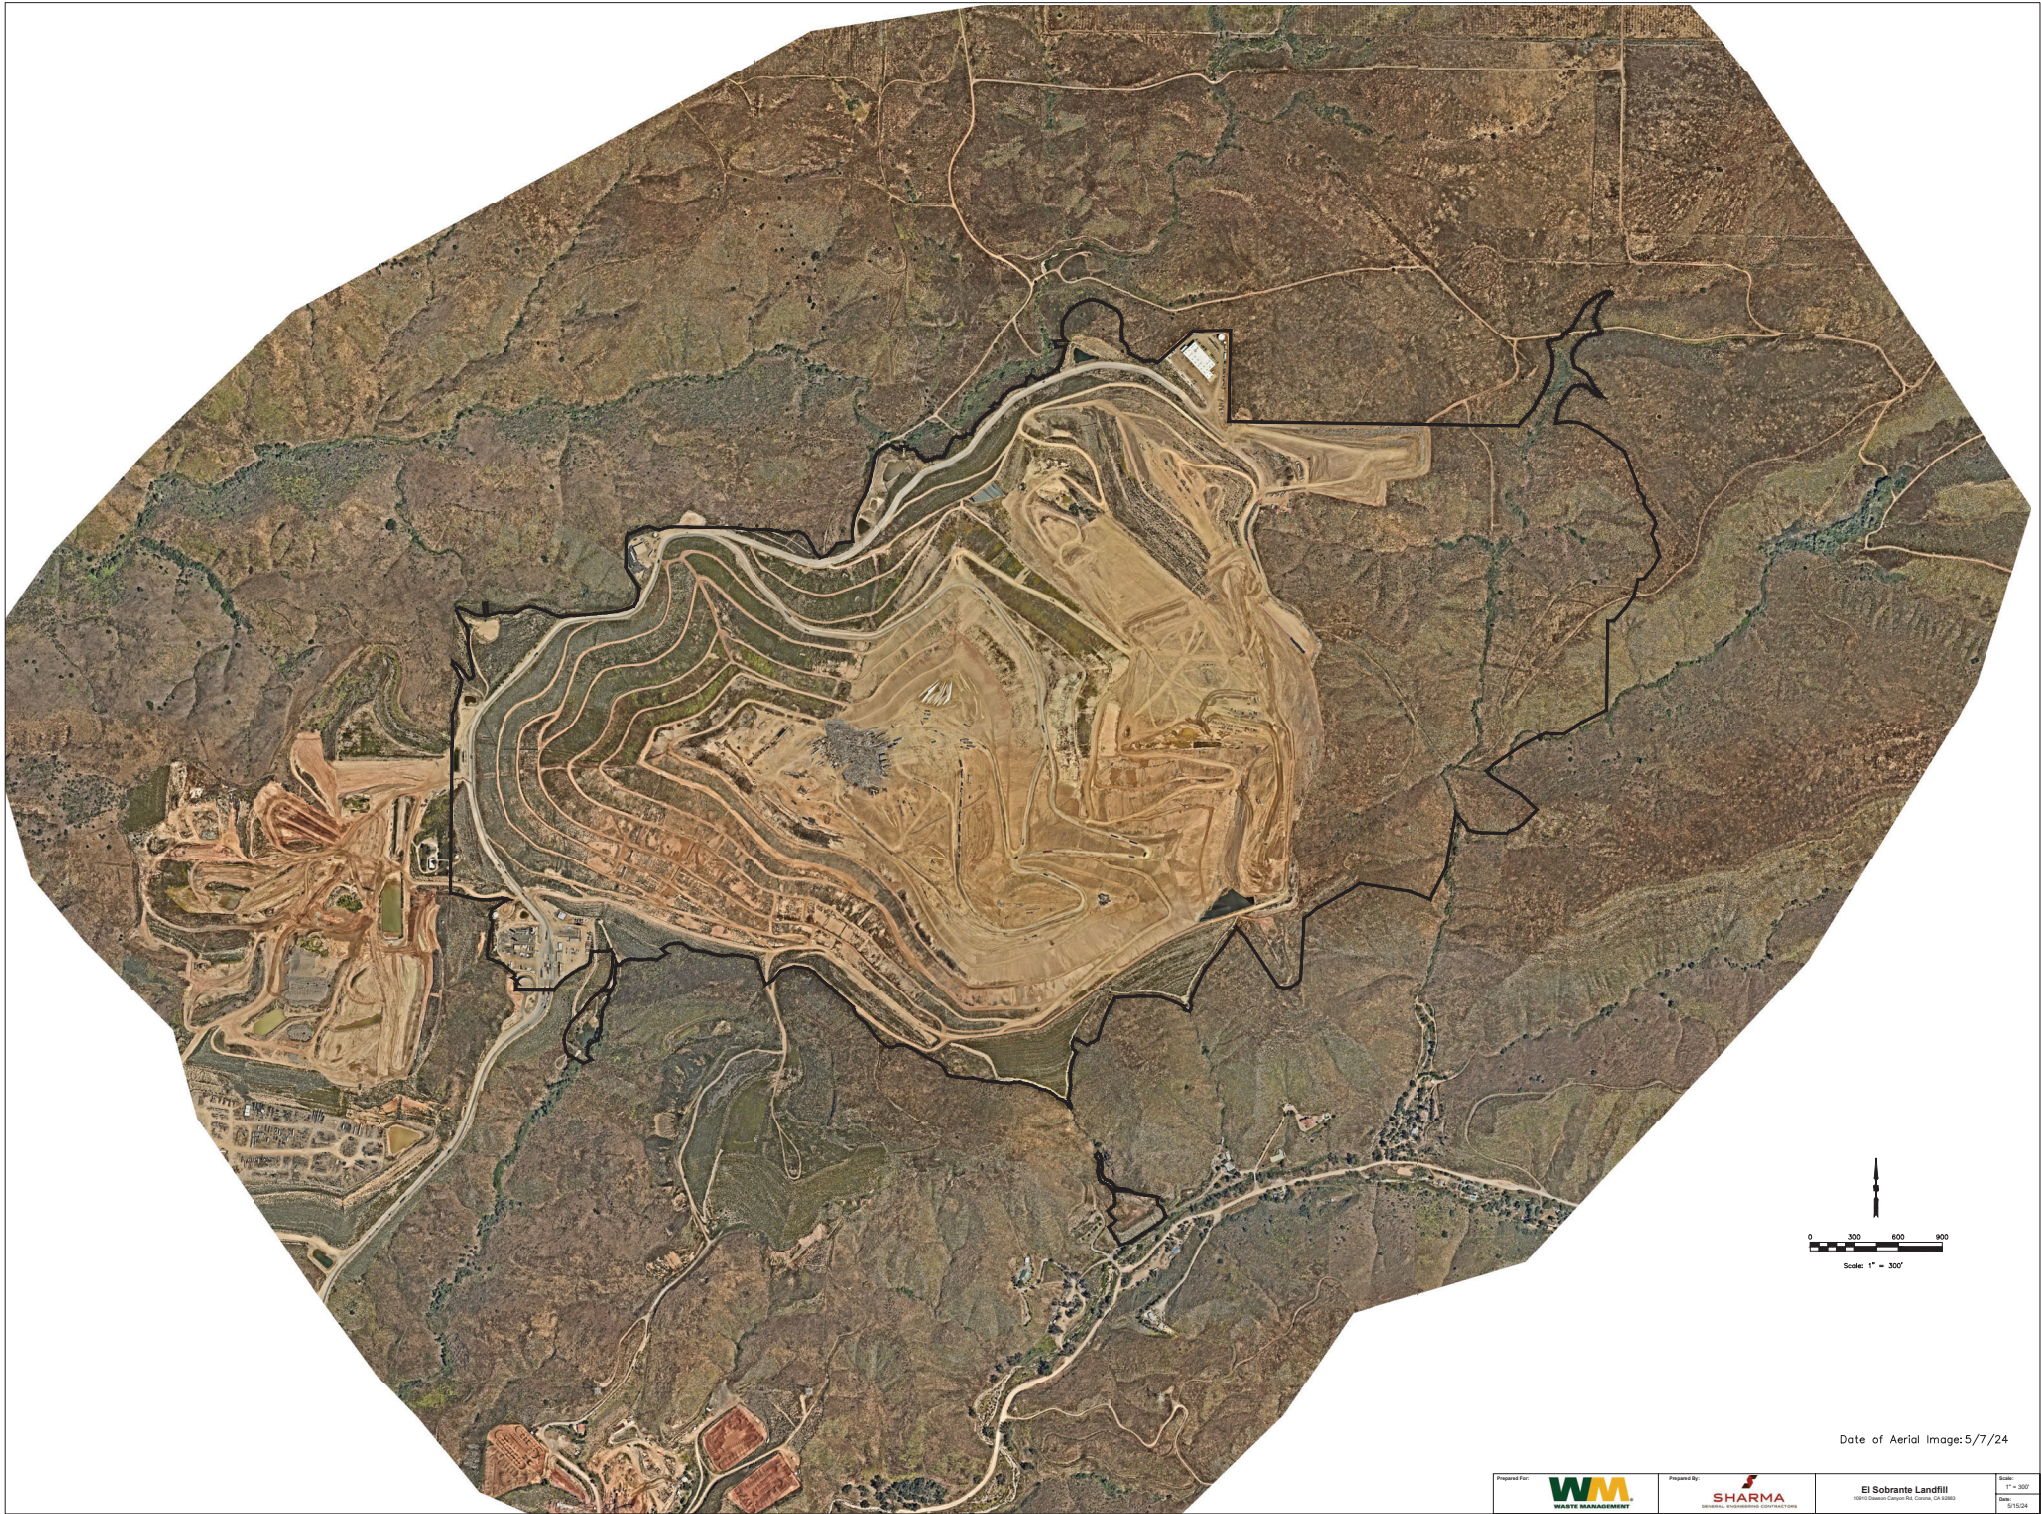
Date of Aerial Image: 5/7/24

- Reviewed 2<sup>nd</sup> quarter 2024 site aerial (see attached).

- An updated aerial was taken on May 7th and showed no areas of offsite grading or operations.
