Community Assessment

El Sobrante Landfill: Community Assessment

Date: May 24, 2023 Arrival time: 10:40 am Prepared by: Katherine Avila/Kinika Hesterly, RCDWR

El Sobrante Landfill
Quarterly Mitigation Monitoring Report

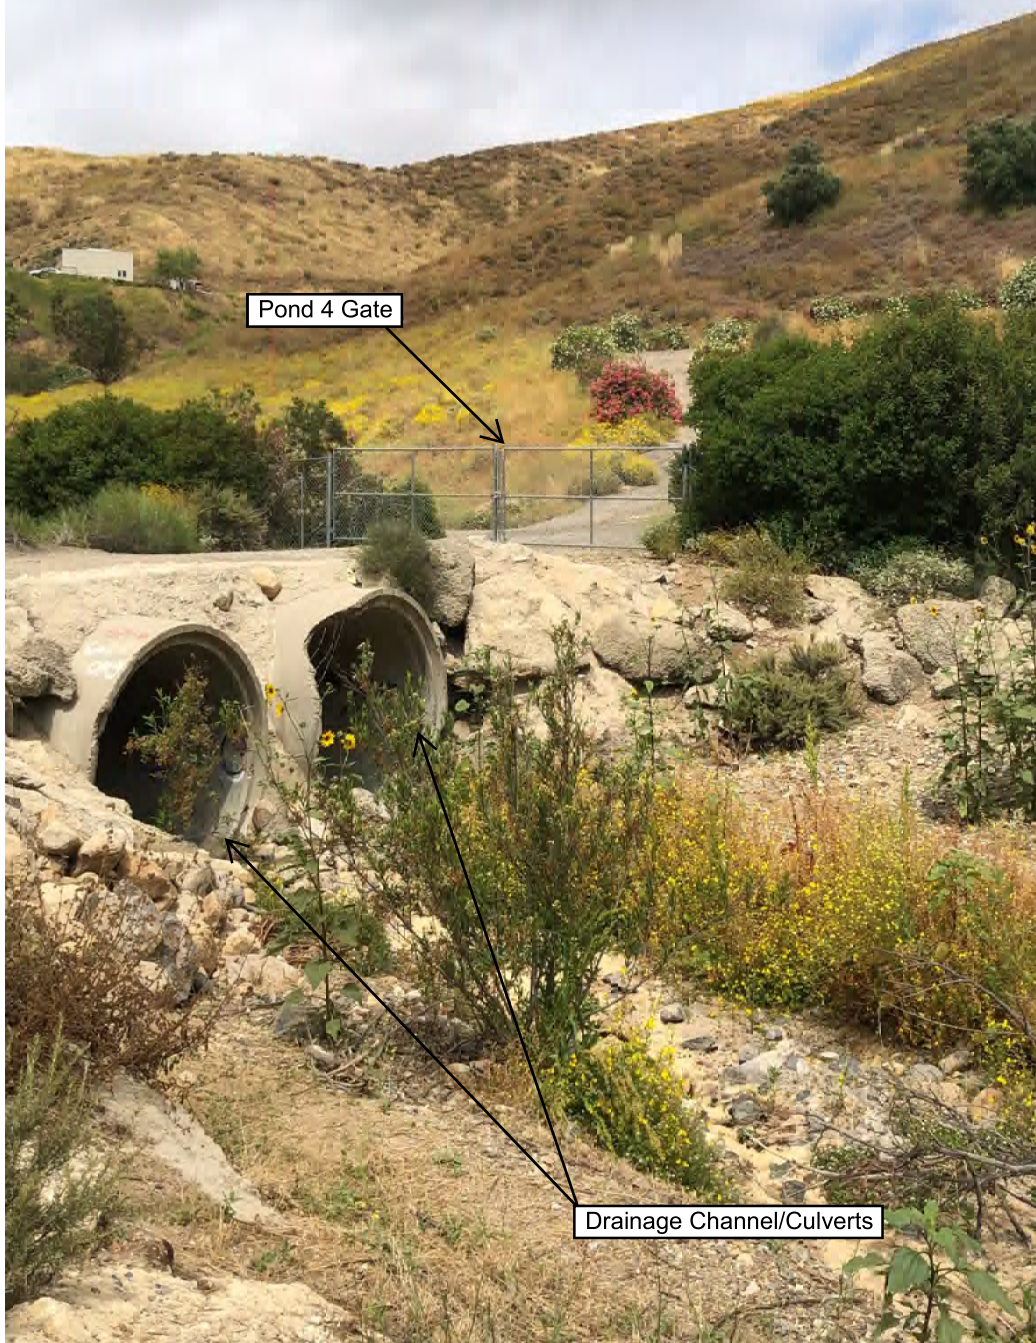
Photo 1

- Pond 4 visual inspection:
 - Pond 4 gate and fencing - good condition, no litter (photo 1).
 - Pond 4 outside slope - good vegetative cover.
 - Green park table with bench is still damaged (photo 2).

- Drainage channel/culverts:
 - Vegetation has grown in the drainage channel but does not cause major debris or blockage.
 - Culvert chipping and graffiti (photo 1).

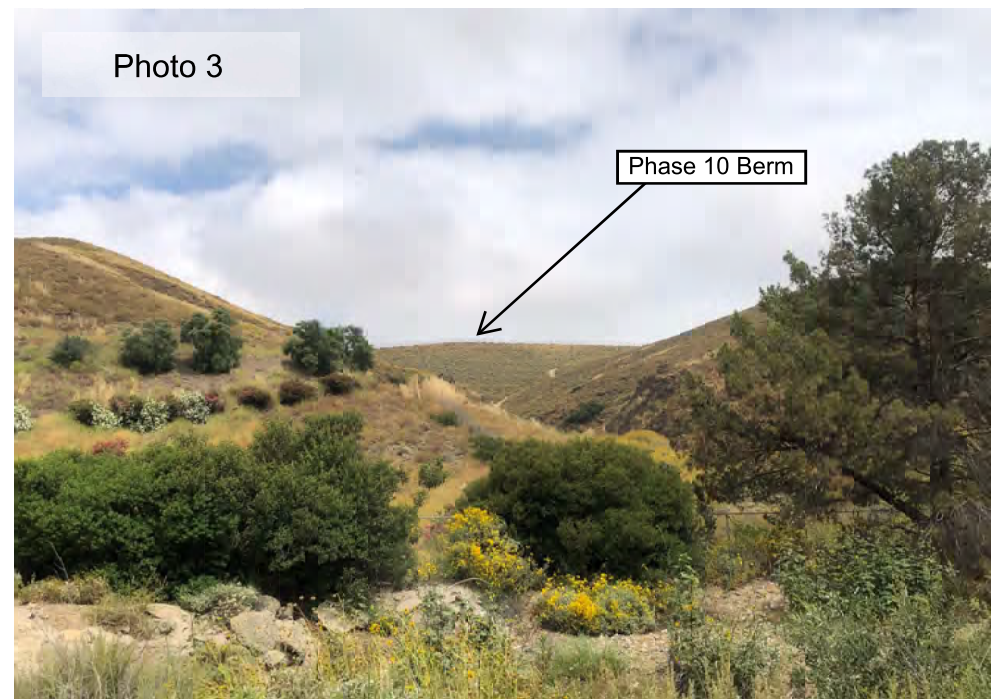
Photo 3

- Berm 10/11:
 - No visible litter, good vegetative cover (photo 3 - Berm 10; photo 5 - Berm 11).
- Landfill operations:
 - Not visible from Dawson Canyon area.

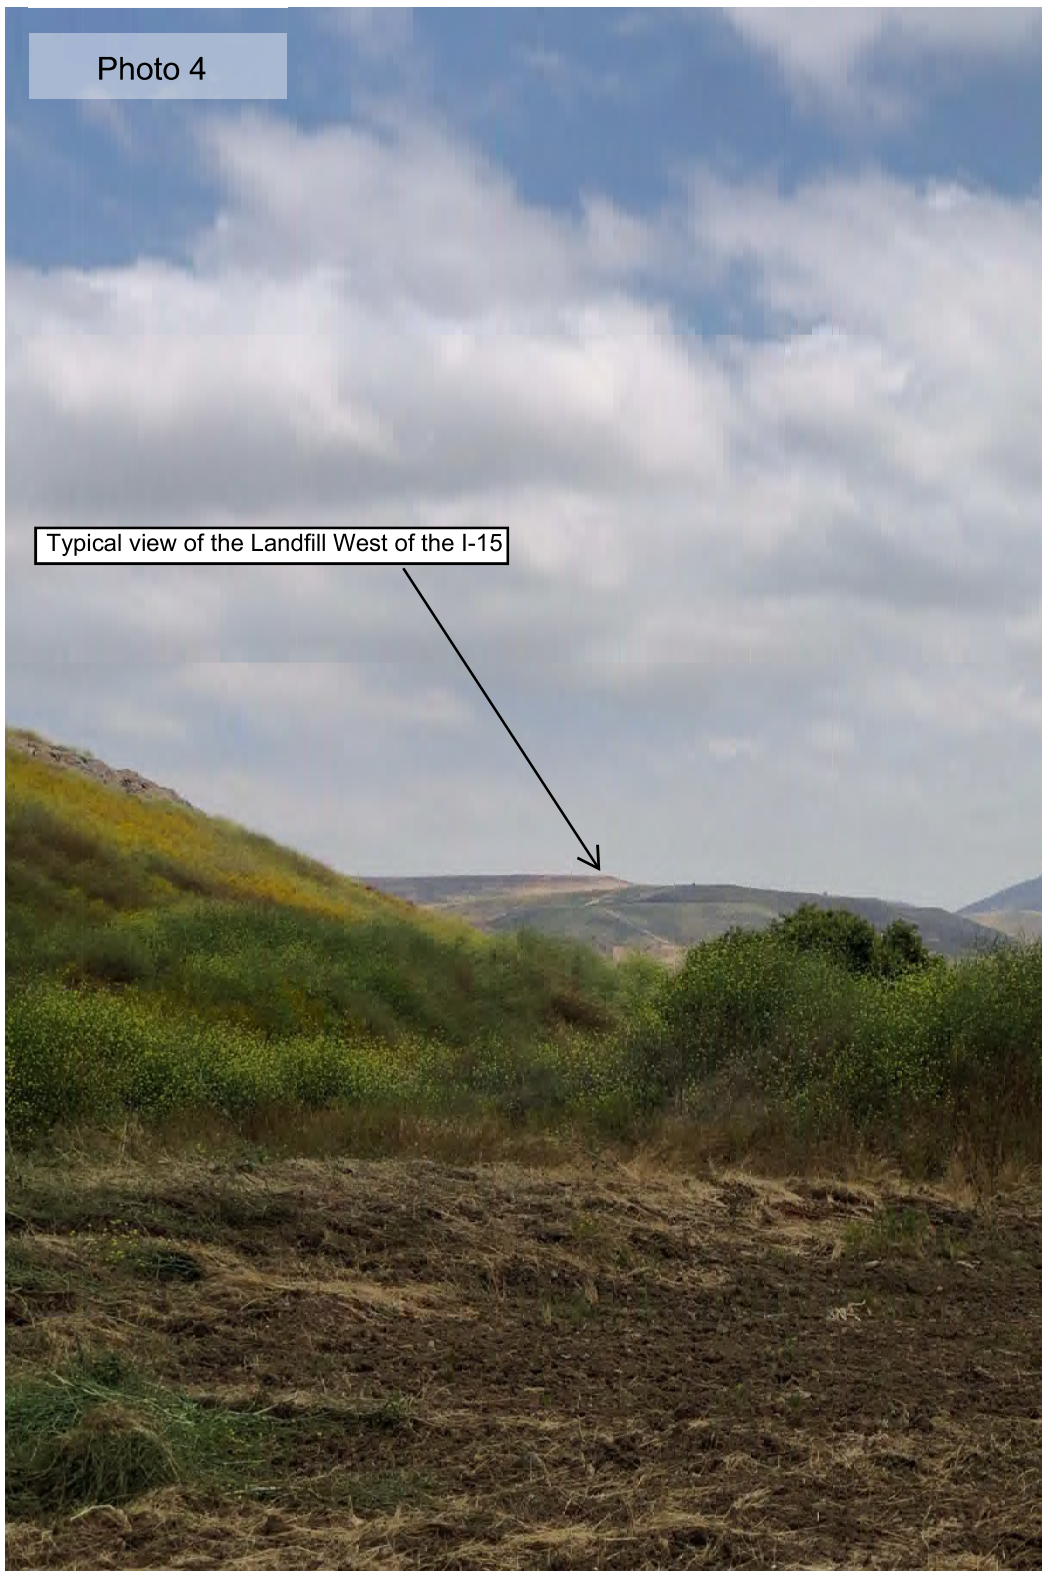
Photo 4

- No major odor in Dawson Canyon (near Pond 4); no odor in Spanish Hills/Trilogy area.
 - Landfill operations not visible from communities west of I-15 (photos 4, 6, and 7); bare outside slopes; USA Waste/WMI implementing plan to address the bare slopes.

Typical view of the Landfill West of the I-15

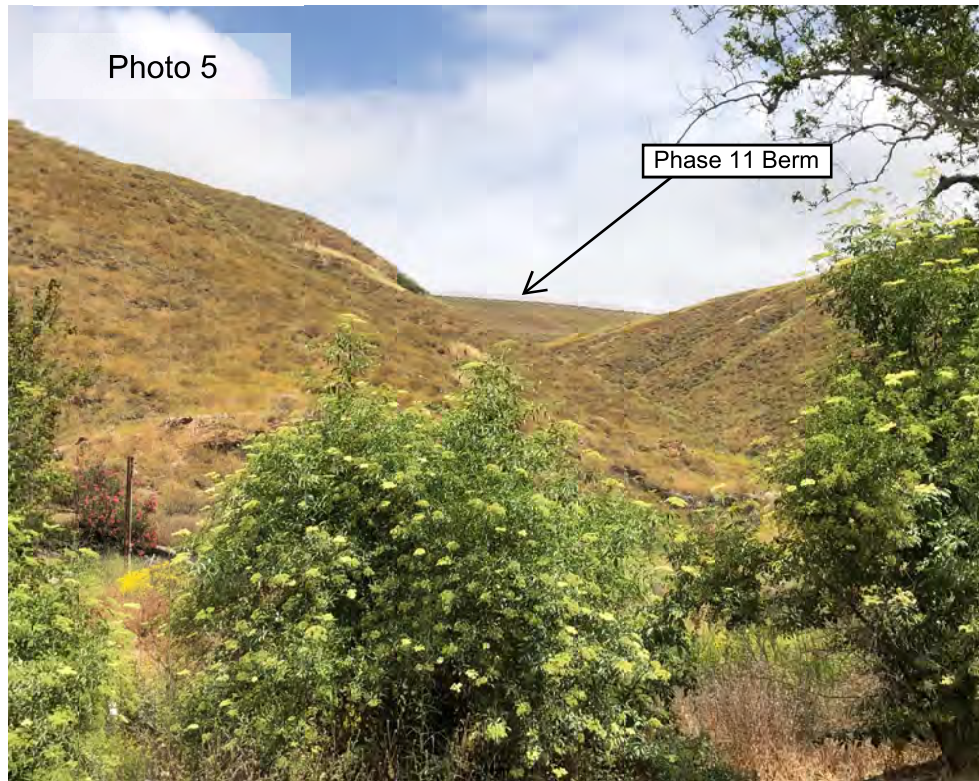
Photo 5

Phase 11 Berm

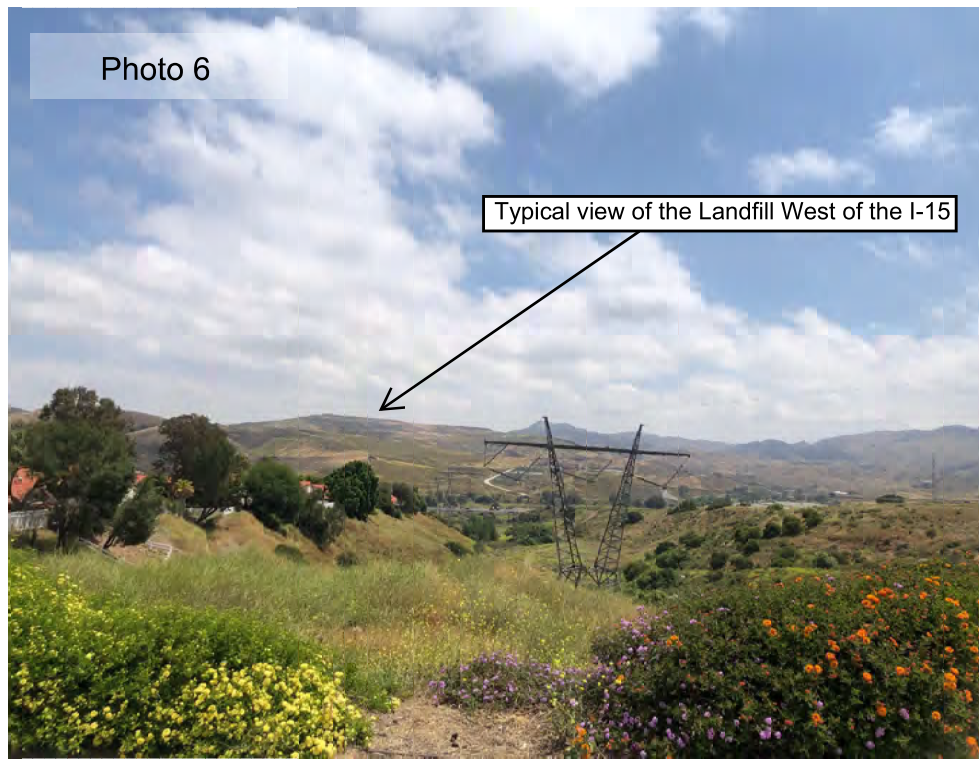
Photo 6

Typical view of the Landfill West of the I-15

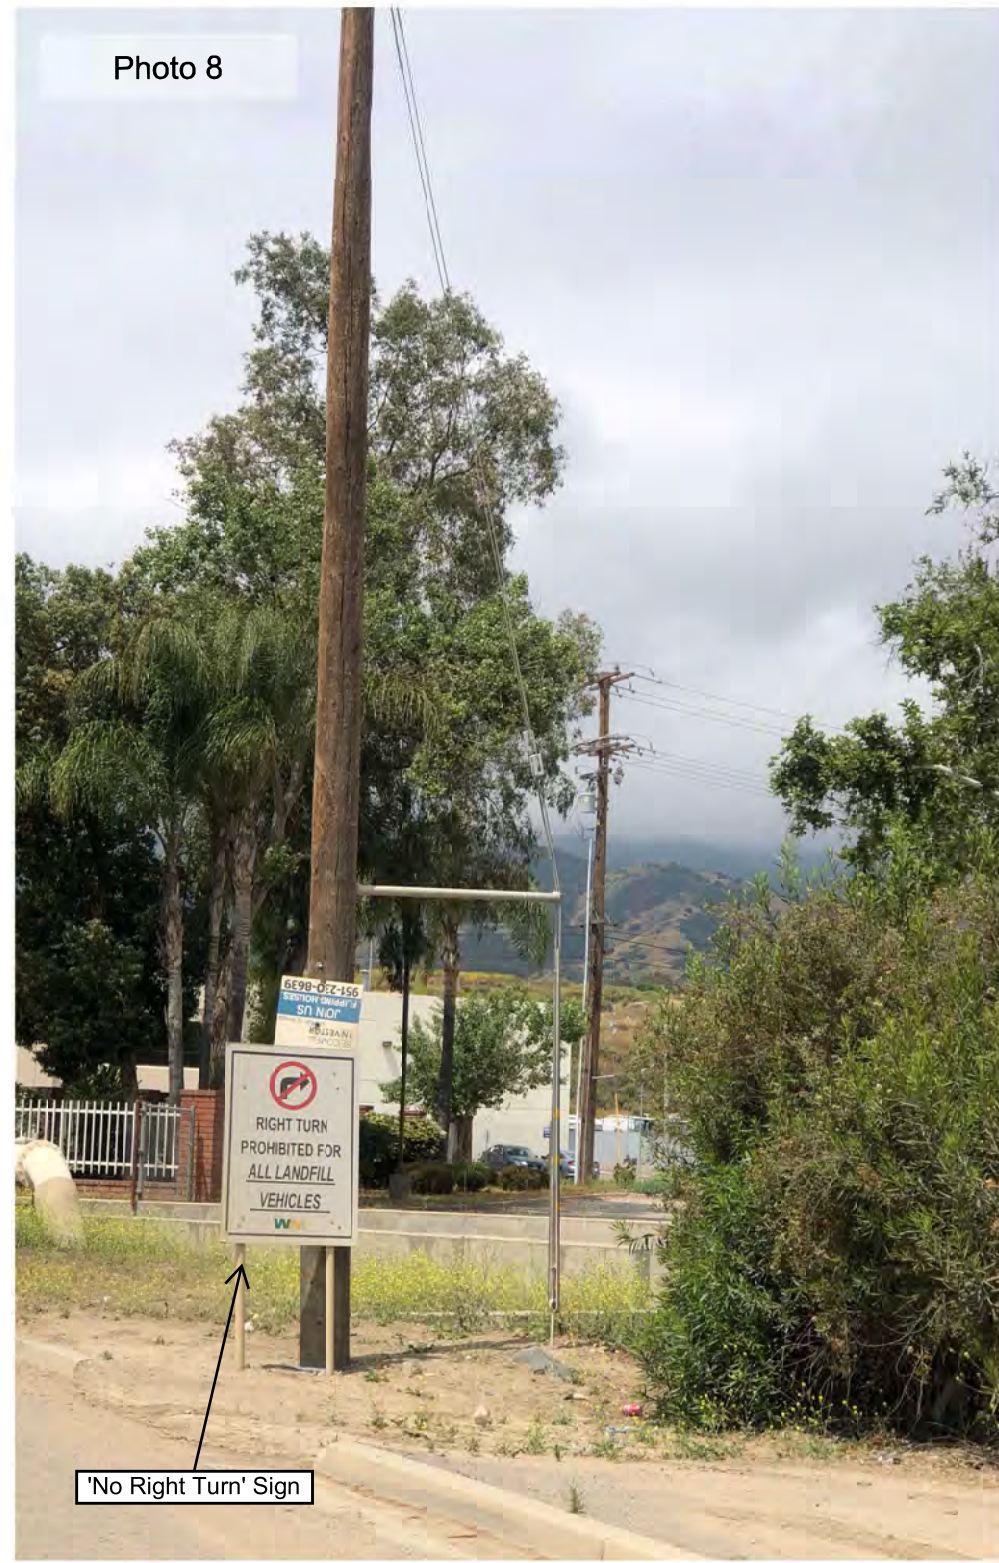
Photo 8

- 'No Right Turn' on Temescal Canyon Road (TCR) from Dawson Canyon:
 - No violations observed.
 - 'No Right Turn' sign is fully visible and in good condition (photo 8).

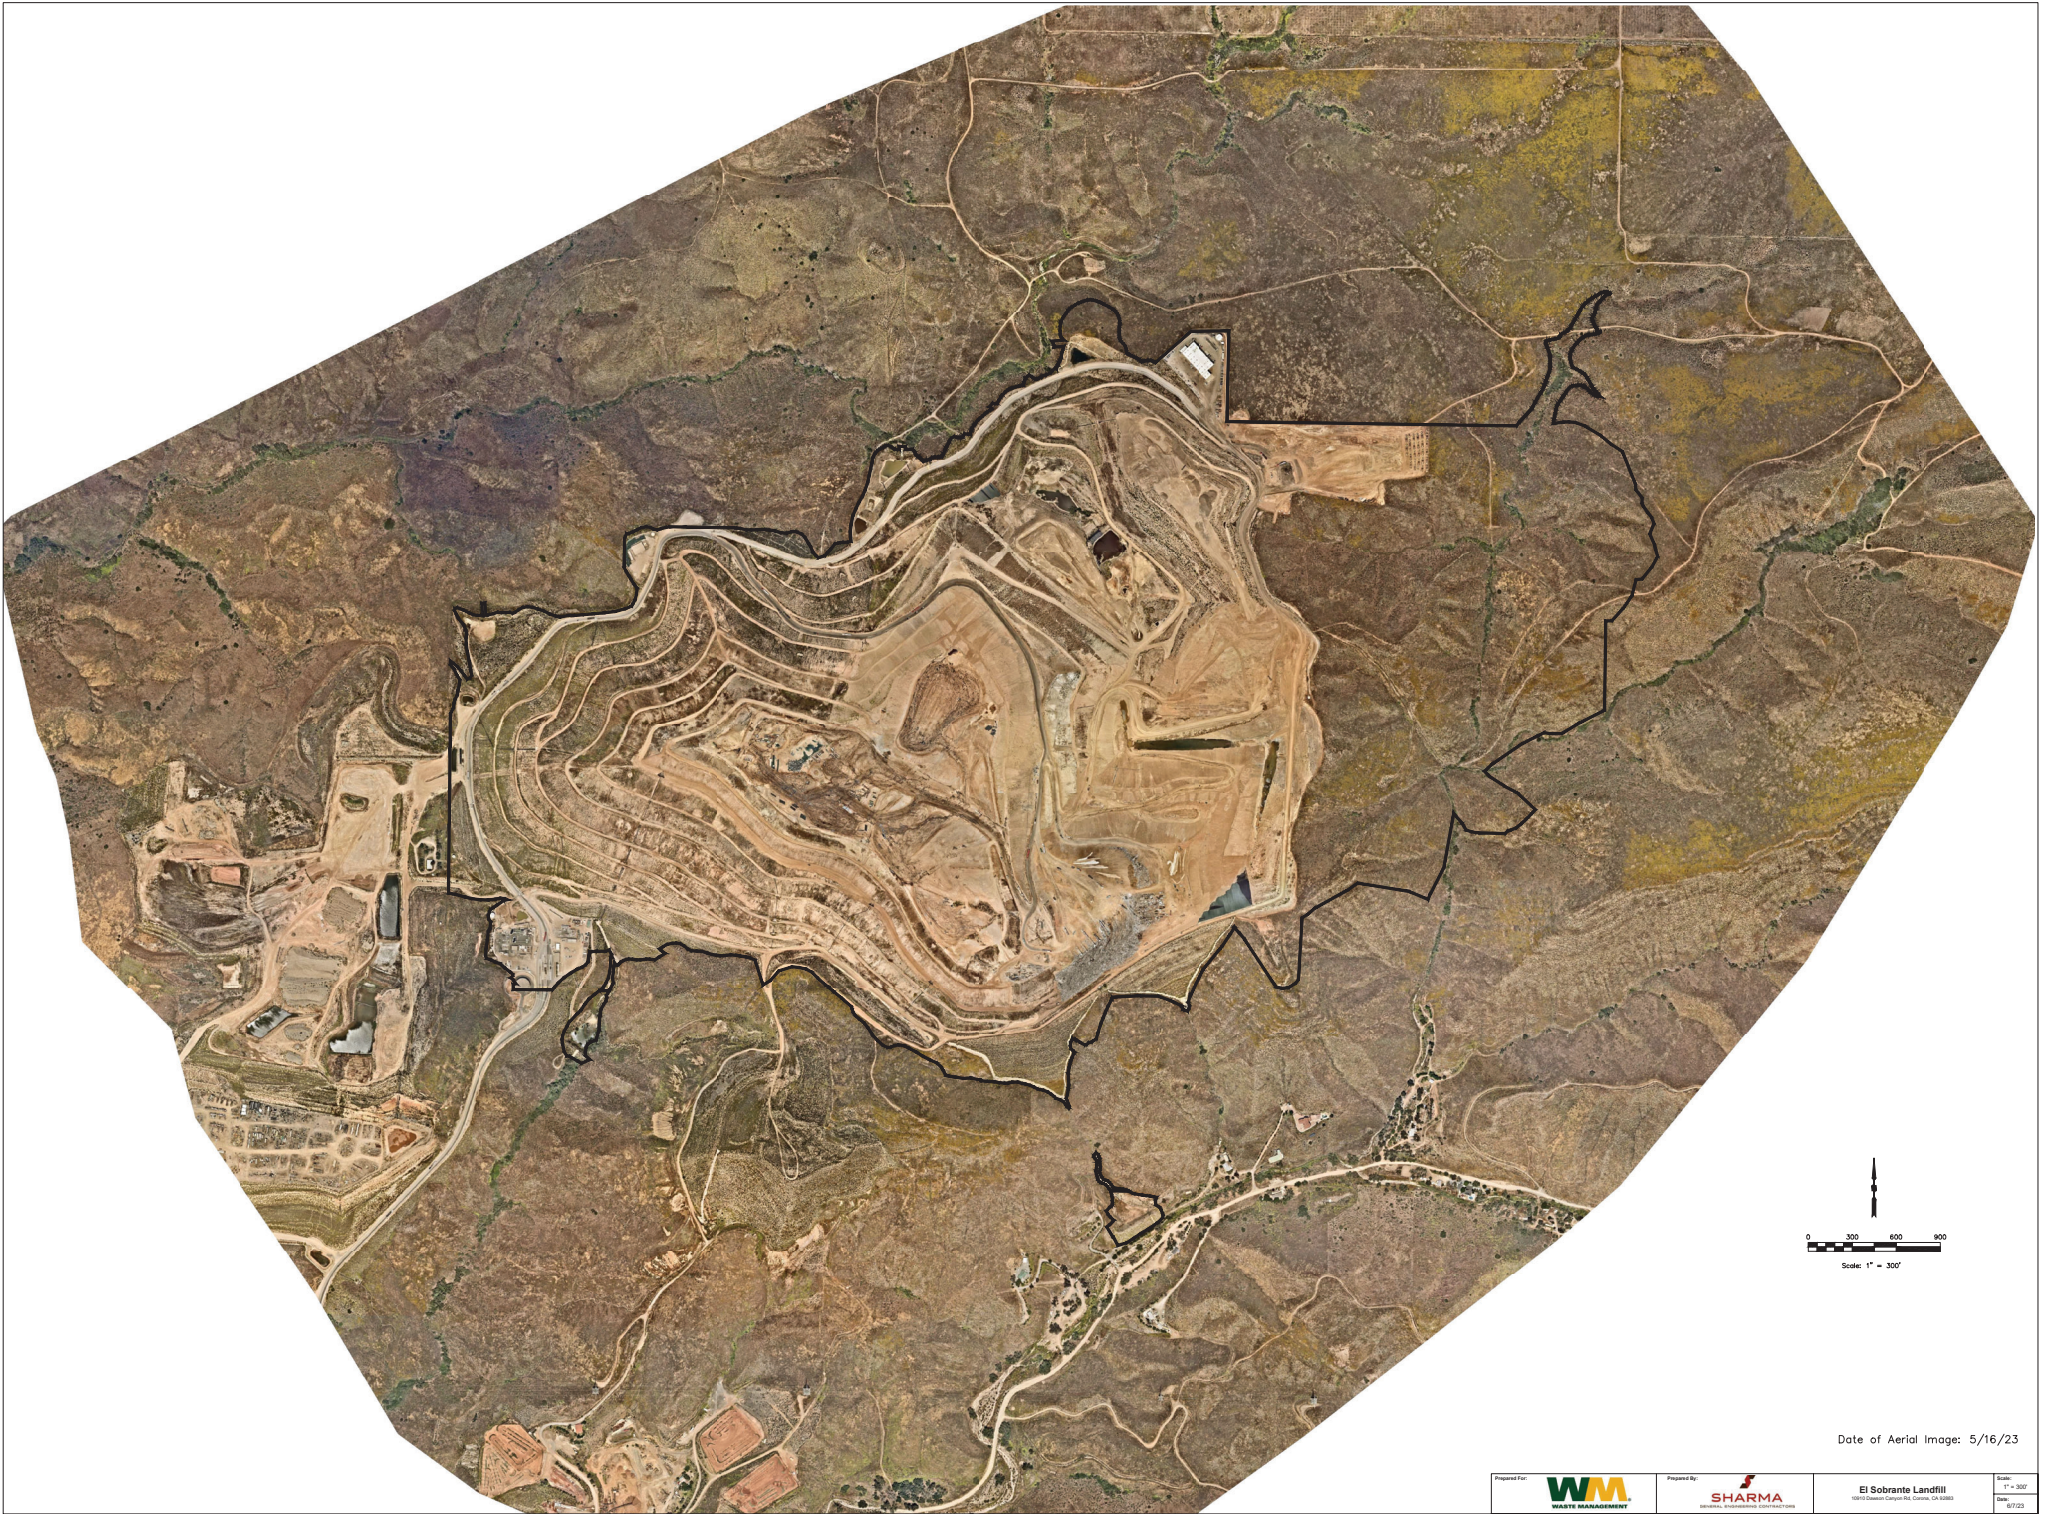
Date of Aerial Image: 5/16/23

- Reviewed 2nd quarter 2023 site aerial (see attached).

- An updated aerial was taken on May 16th and showed no areas of offsite grading or operations.
